- Final Report from Don Luxton and Associates Inc. Heritage Assessment Report

Regarding the Menzies Residence dated: April 20 2016

Civic Address: 19963 Mc Neil Rd., Pitt Meadows

Heritage Assessment: The Menzies Residence, 19963 McNeil Road, Pitt Meadows

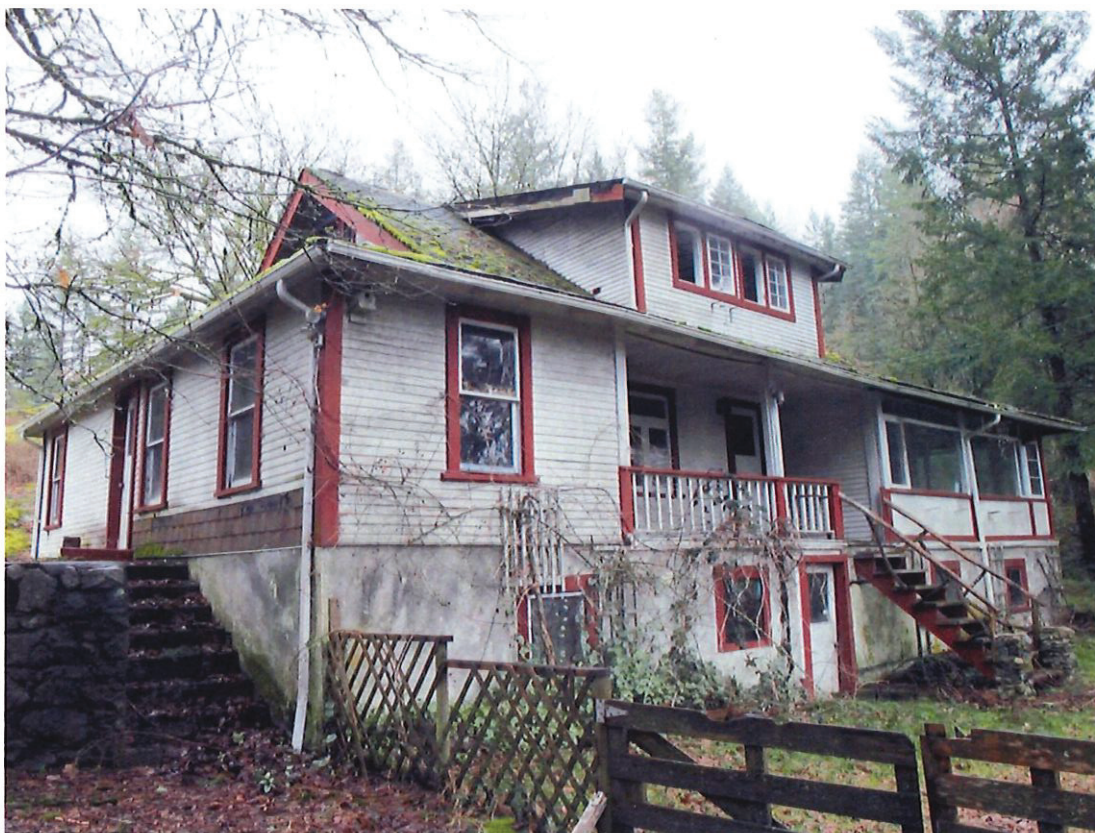
Menzies Residence
19963 McNeil Road
Circa 1910
Listed on the Pitt Meadows Community Heritage Register

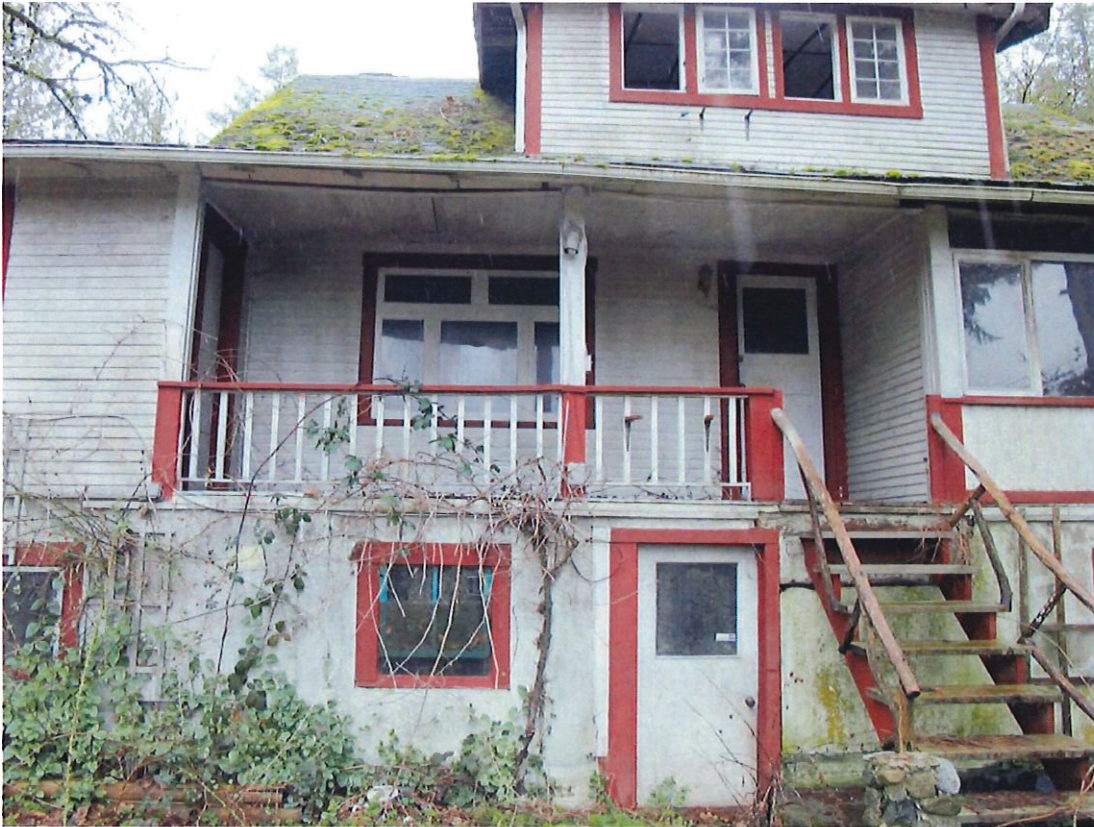
The addition to the west extends the original rooflines, and returns them in a hipped roof, which alters the form and scale of the original house. Similarly, the addition to the east extends the roof form and alters the scale of the house. It appears that the original east and west walls of the house have been substantially altered or removed.

Overall the house in its current configuration lacks a great deal of its original integrity. In addition to the changes to form, scale and massing, there are also other alterations to windows, doors, stairs and balustrades. These alterations are not considered to have heritage significance, and detract from the original appearance and character of the house.

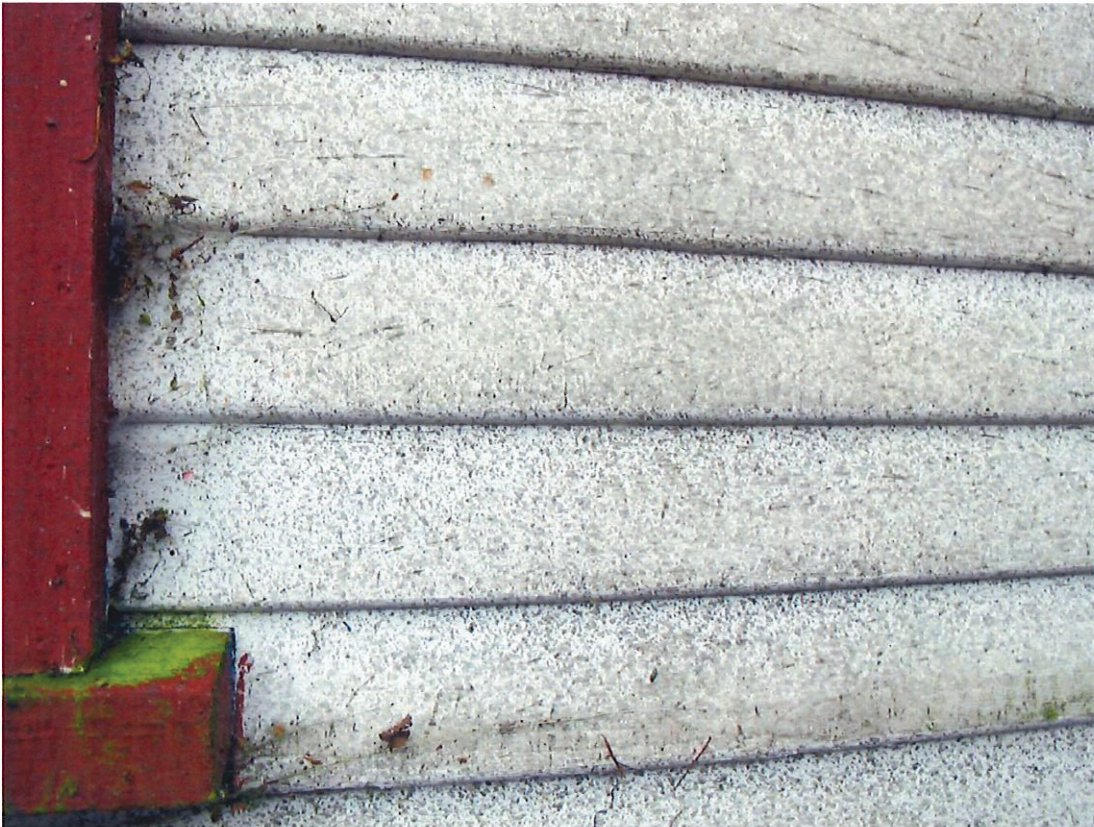
The house has been open to the elements, apparently for a period of several years. Windows are open and have allowed water infiltration. The roof shingles are failing. There is some structural sagging evident in the rooflines, and some internal structural failure. Overall, the construction materials are compromised, and appear to be in poor condition.

Throughout the exterior siding and the interior features, it appears that mould has become established, and is evident on most surfaces. The extent to which this has compromised the materials is unknown.
