Drawing title: Tree Management Plan

Project address: Pitt Meadows Civic Centre, 19125 119B Ave

Client: Metro Vancouver

Arboricultural Inventory and Report

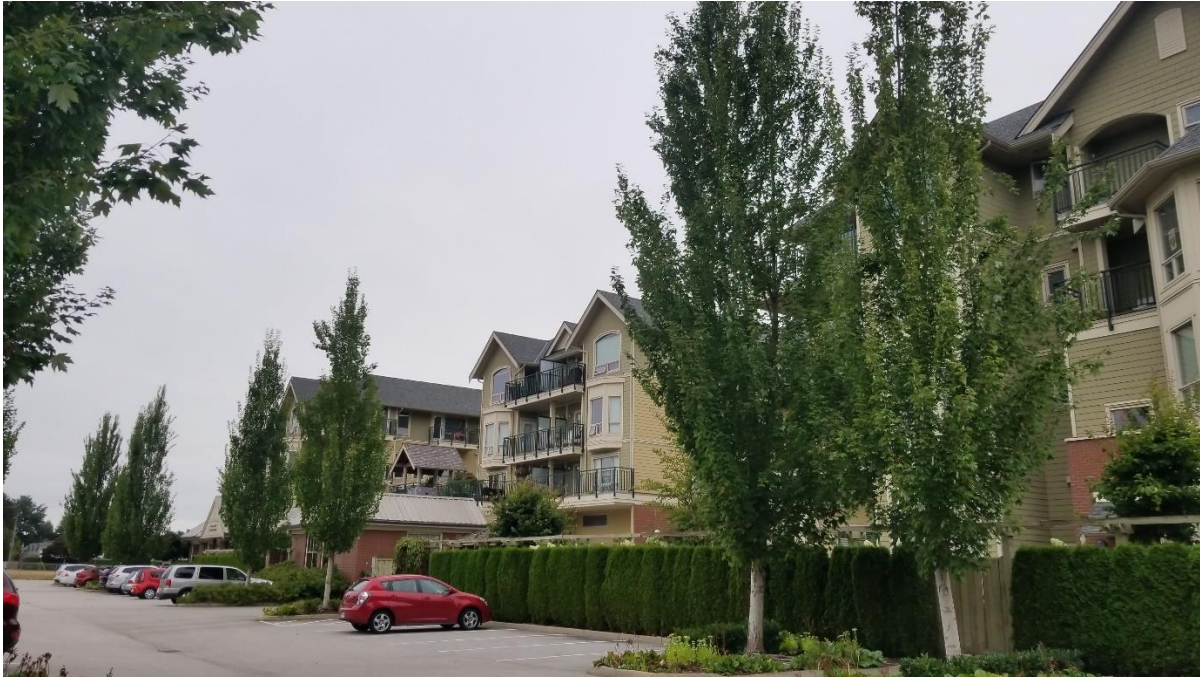
| Surveyed (Y/N) | Tag # | Location | Species Common Name | Botanical Name | DBH (cm) | Height (m) | Dripline Radius (m) | Health and Structure Rating | Comments | Retention Value Rating | Retain/ Remove | Retention/TPZ Comments | *TPZ (m) |
|---|---|---|---|---|---|---|---|---|--|---|---|--|---|
| Y | 5842 | On Site-City owned | Red Maple | Acer rubrum | 18 | 12 | 2 | Moderate | Growing in garden bed. Columnar form with narrow unions. Codominant leaders at 9 m. | Medium | Retain | Protect as required. TPZ fencing to be aligned with edge of hardscaping. | 2 |
| Y | 5843 | On Site-City owned | Red Maple | Acer rubrum | 18 | 12 | 2 | Moderate | Growing in garden bed. Columnar form with narrow unions. Codominant leaders at 2 m. | Medium | Retain | Protect as required. TPZ fencing to be aligned with edge of hardscaping. | 2 |

Photo 1. Looking southwest at Trees 5842-5847

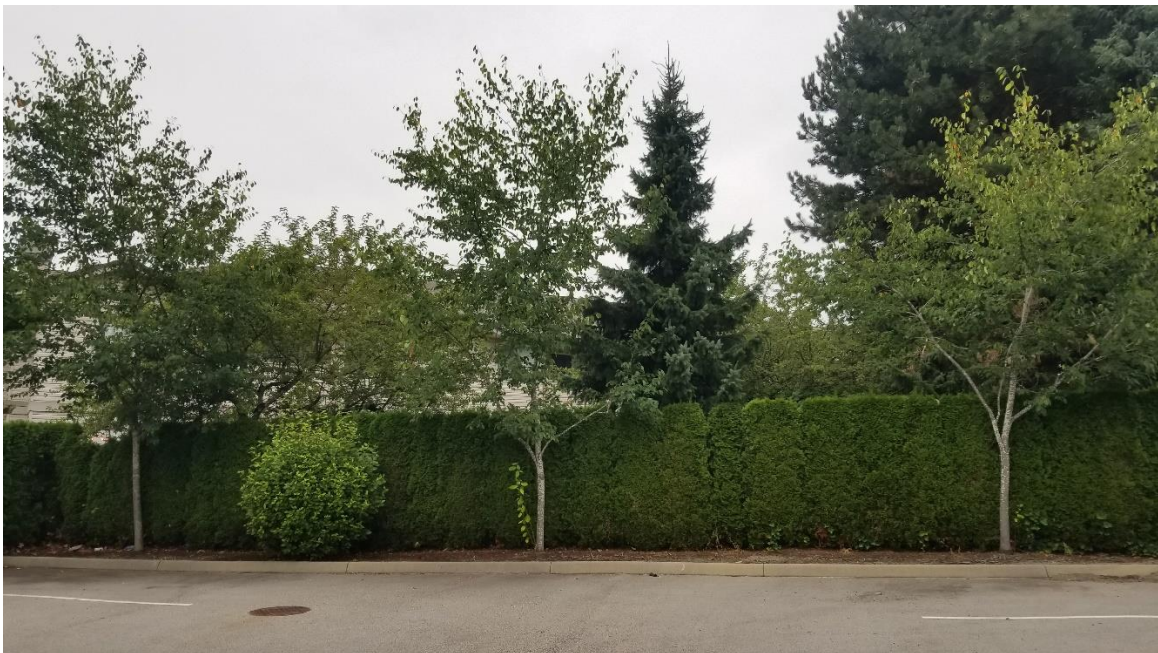
Photo 2. Undersized trees in foreground with OS 1 & OS 2 in background

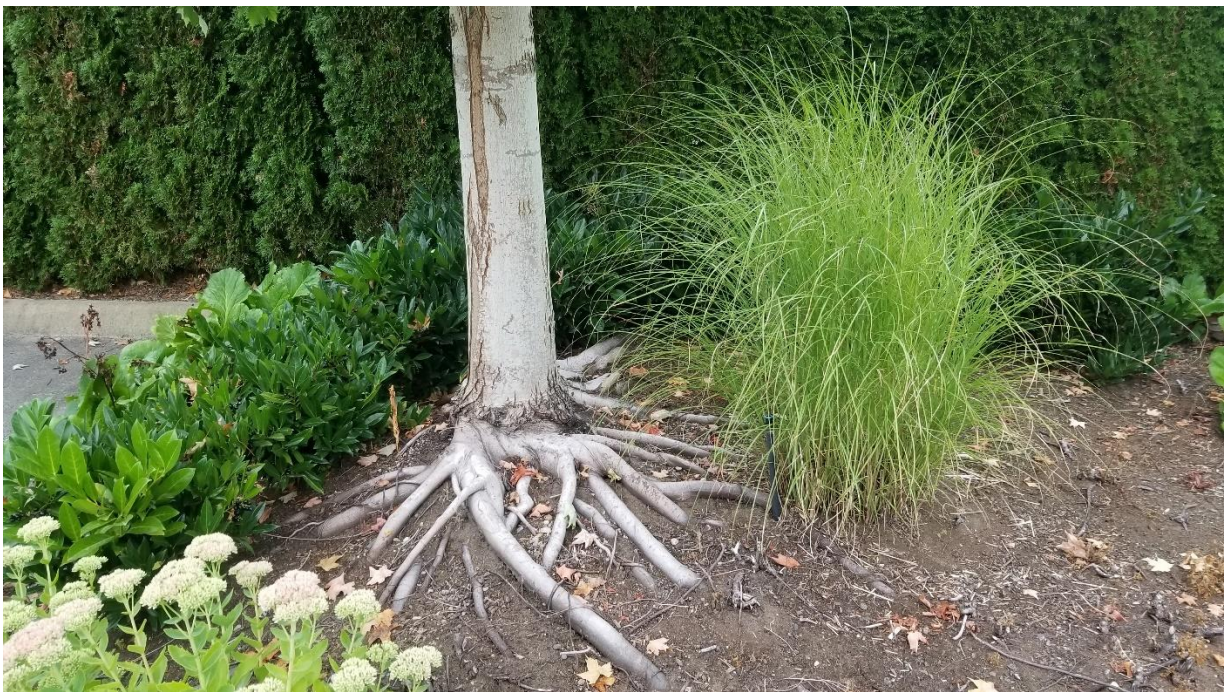
Photo 3. Example of exposed surface roots on Maple trees

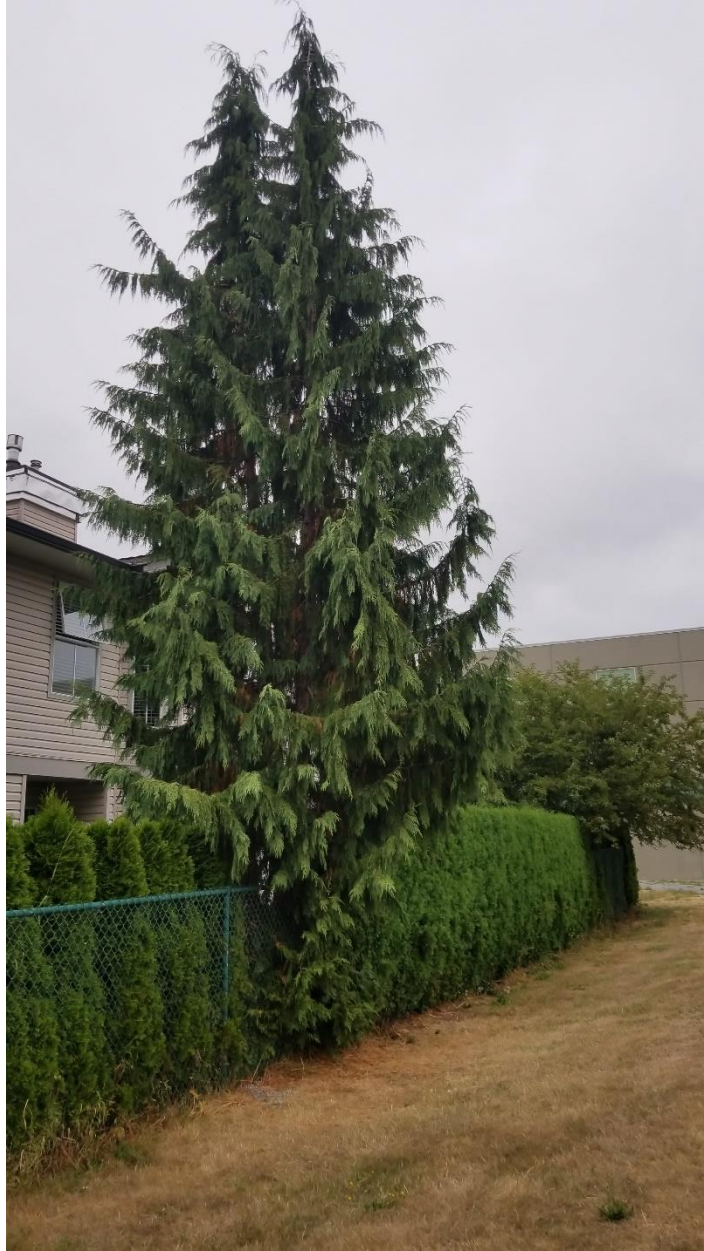
Photo 4. Looking northeast at OS 4 & OS 5 with OS hedge

All off-site trees are recommended to be retained with tree protection fencing installed.

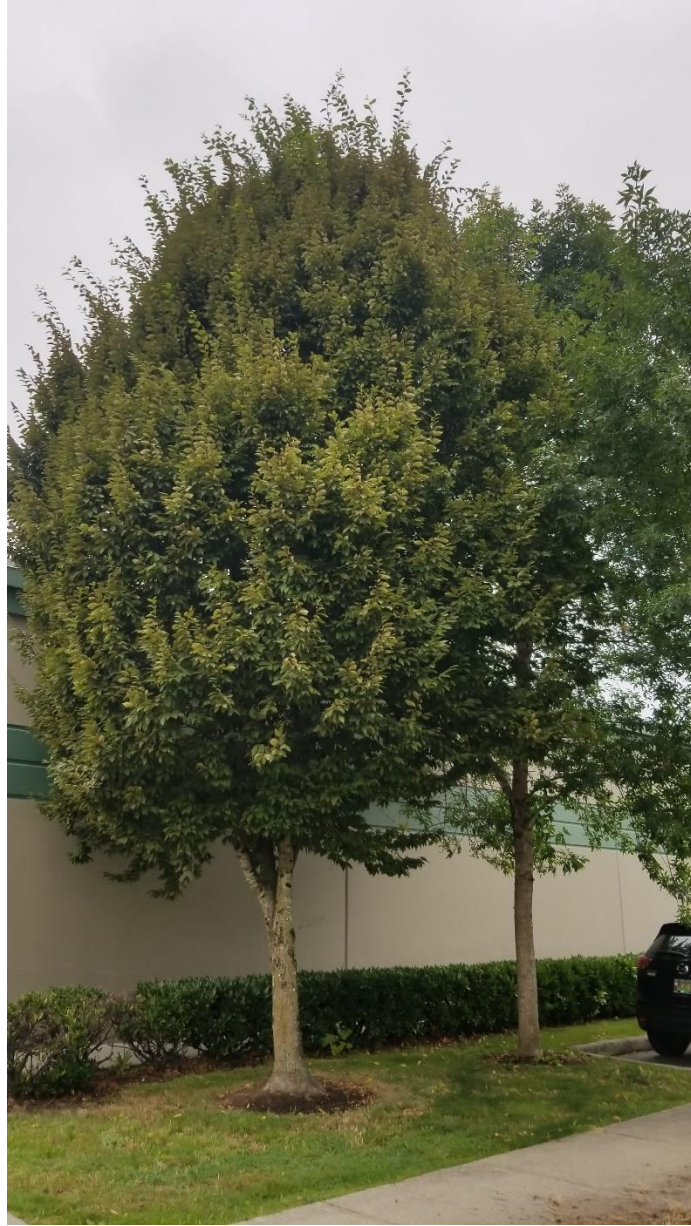
Photo 5. Tree C1 & C2

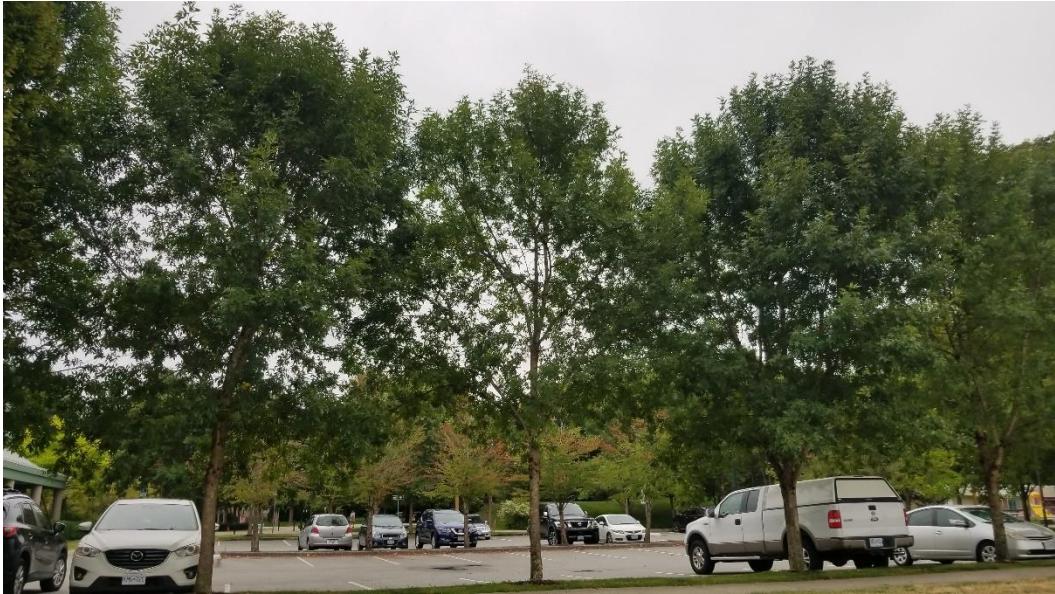
Photo 6. Looking east at City trees 3-6

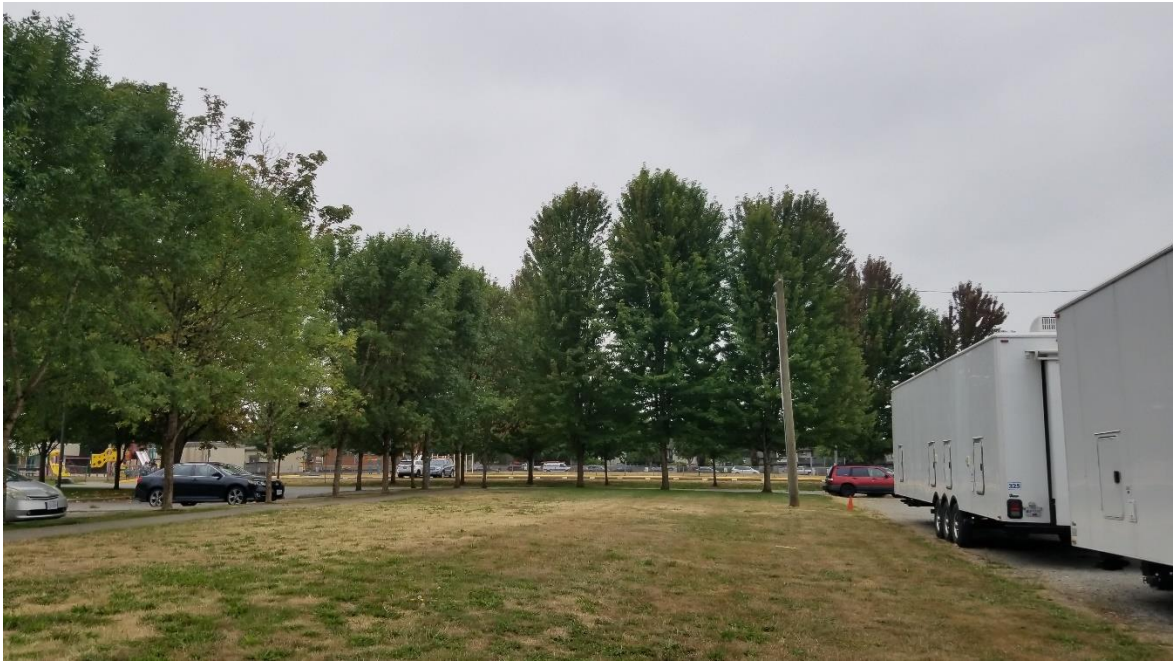
| Surveyed (Y/N) | Tag # | Location | Species Common Name | Botanical Name | DBH (cm) | Height (m) | Dripline Radius (m) | Health and Structure Rating | Comments | Retention Value Rating | Retain/ Remove | Retention/TPZ Comments | *TPZ (m) |
|---|---|---|---|---|---|---|---|---|---|---|---|--|---|
| Y | C18 | City | Red Maple | Acer rubrum | 32 | 16 | 5 | Good | Growing in grass boulevard as part of planted row. Codominant stems at 3 m. Crowns suppressed to become narrow because of neighbouring trees. | High | Remove | Conflicts with underground parking lot. | 2 |

Photo 7. Looking south towards City trees 15-18 with row of Ash trees showing on left

All off-site city owned trees are recommended to be retained except for C18 which is recommended to be removed as it will conflict with the underground parking lot. Permission is required to be obtained from the city to remove this tree.

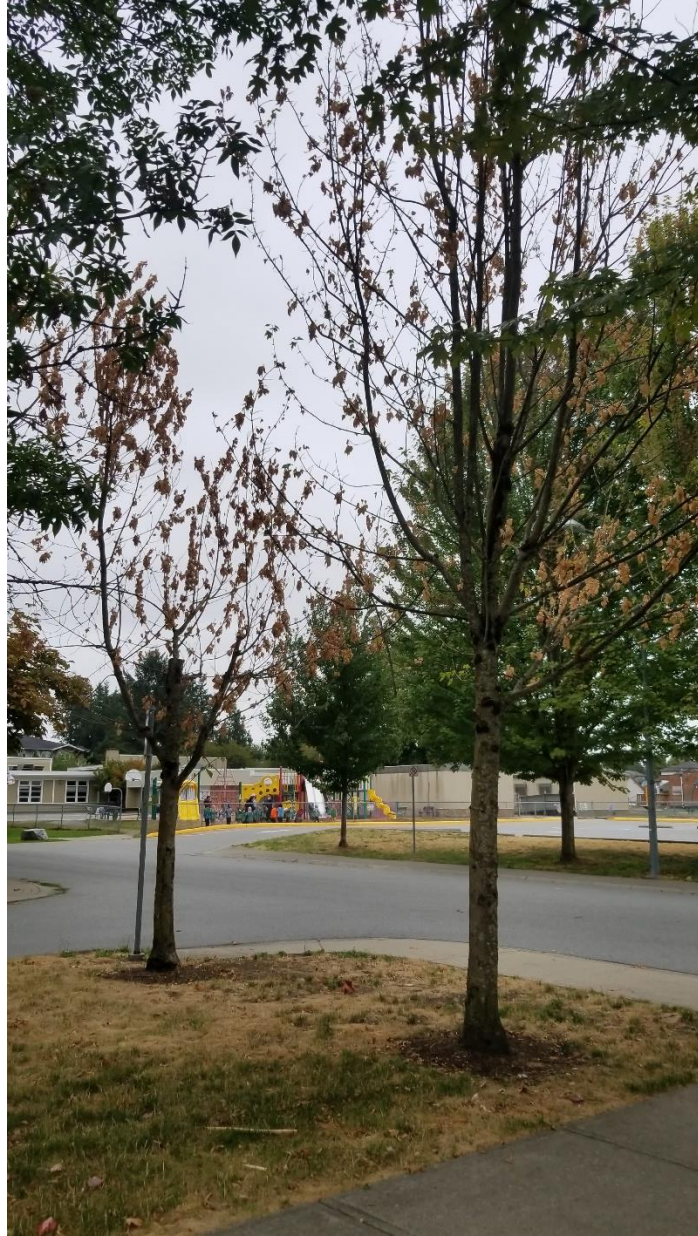
Photo 8. City trees 13 & 14
