Onni Group
300 - 550 Robson Street
Vancouver, BC
V6B 2B7

June 17, 2015
File:11219

**Re: Geotechnical Investigation Report: Proposed Golden Ears Business Park Phase III and IV
Airport Way East of Harris Road, Pitt Meadows, B.C.**

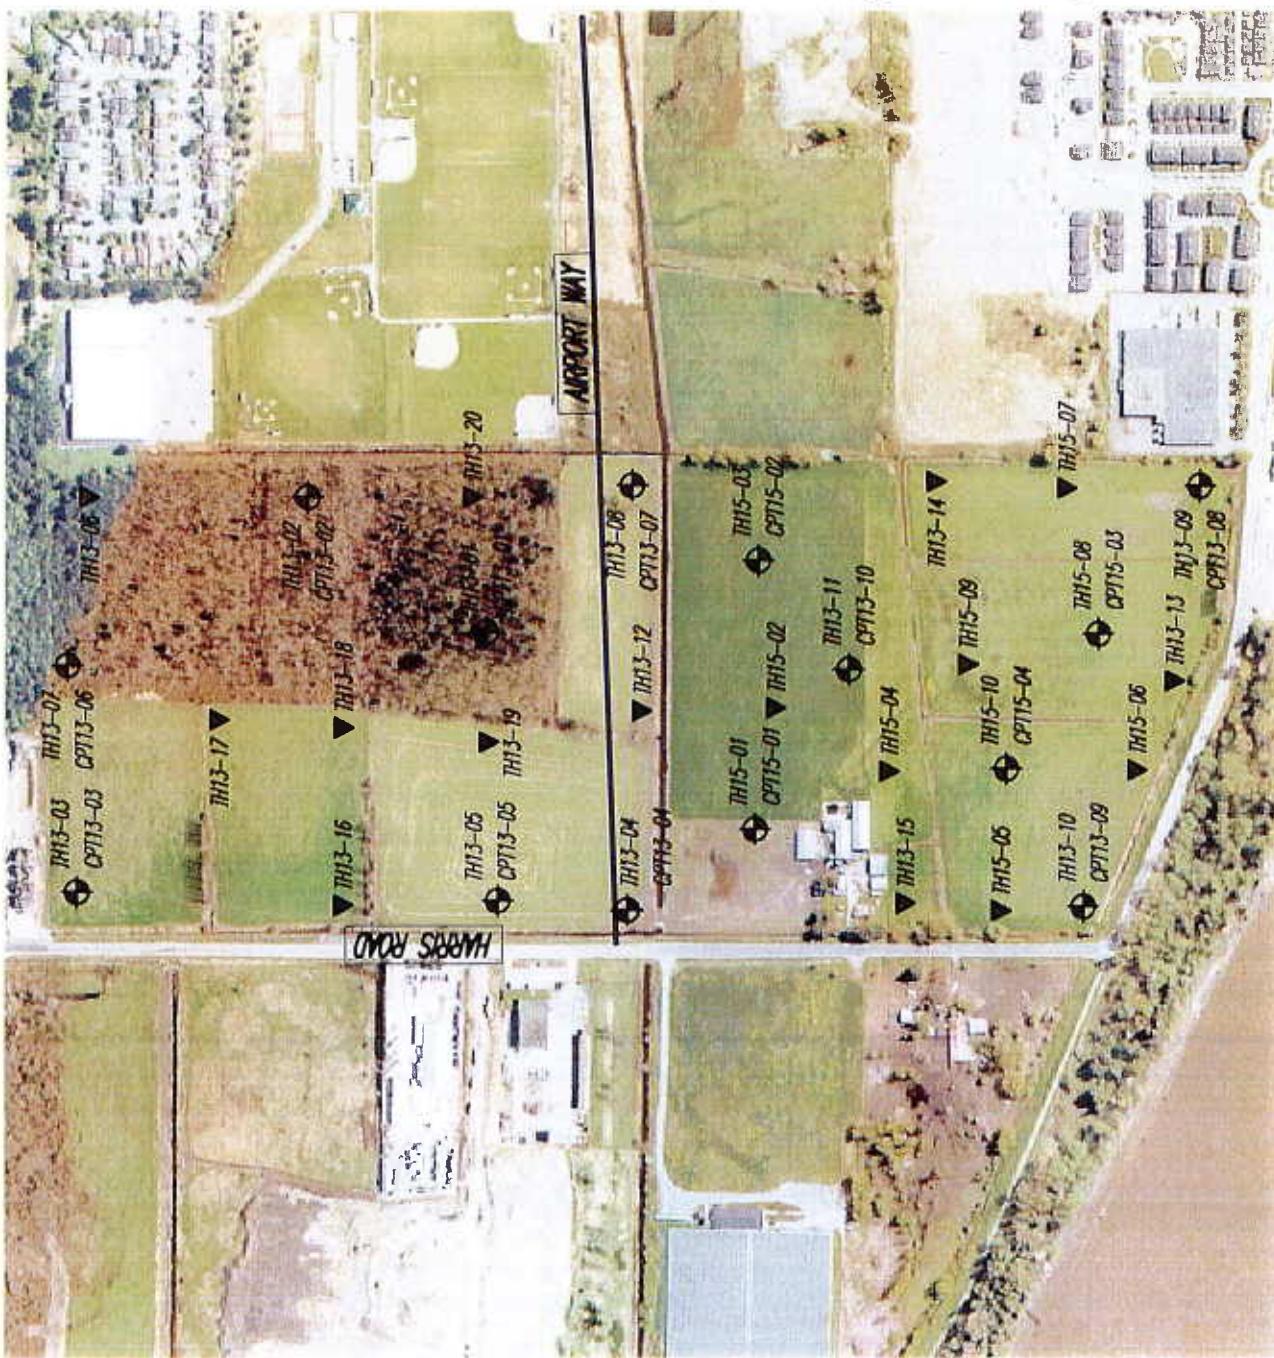
The location of the proposed development site is shown on our Drawing No. 11219-01 and 11219-02A located following the text of this report.

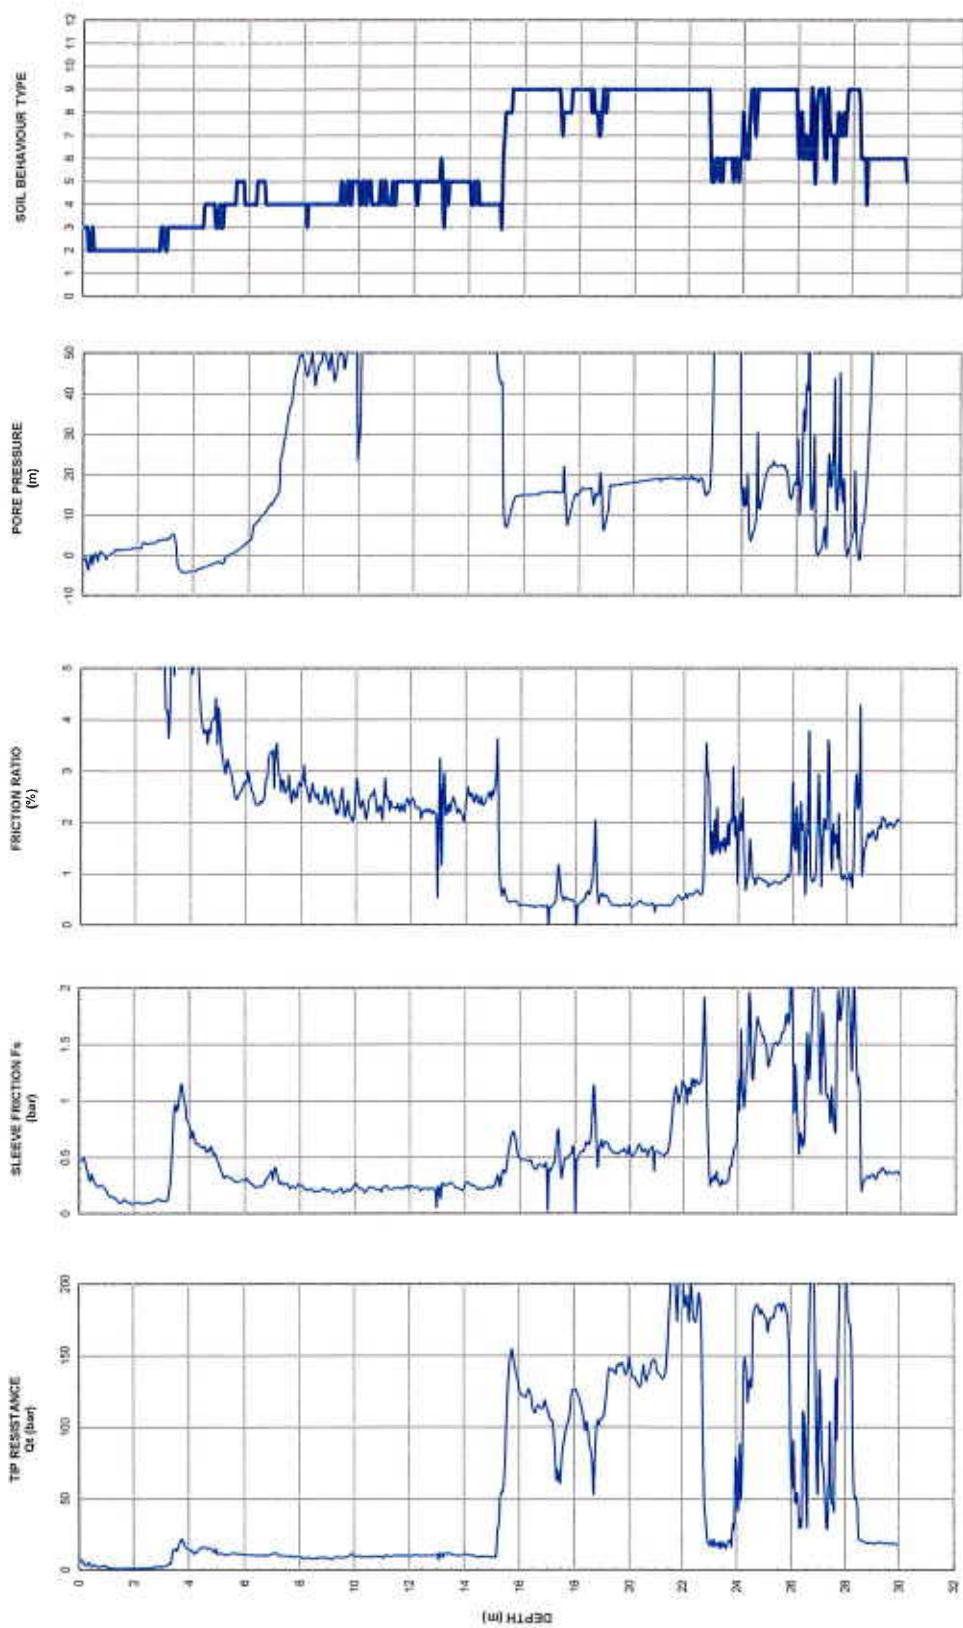
15-Apr-13	Onni Group of Companies	GeoPacific Project #: 11219
GeoPacific Consultants Ltd.	Sounding: CPT13-02	Airport Way East of Harris Road, Pitt Meadows, B.C.	Figure: B.02

** Based on Robertson et. al 1986
 1 Sensitive Fine Grained
 2 Organic Material
 3 Clay
 4 Silty Clay to Clay
 5 Clayey Silt to Silty Clay
 6 Sandy Silt to Clayey Silt
 7 Silty Sand to Sandy Silt
 8 Sand to Silty Sand
 9 Sand
 10 Gravelly Sand to Sand
 11 Very Stiff Fine Grained
 12 Sand to Clayey Sand

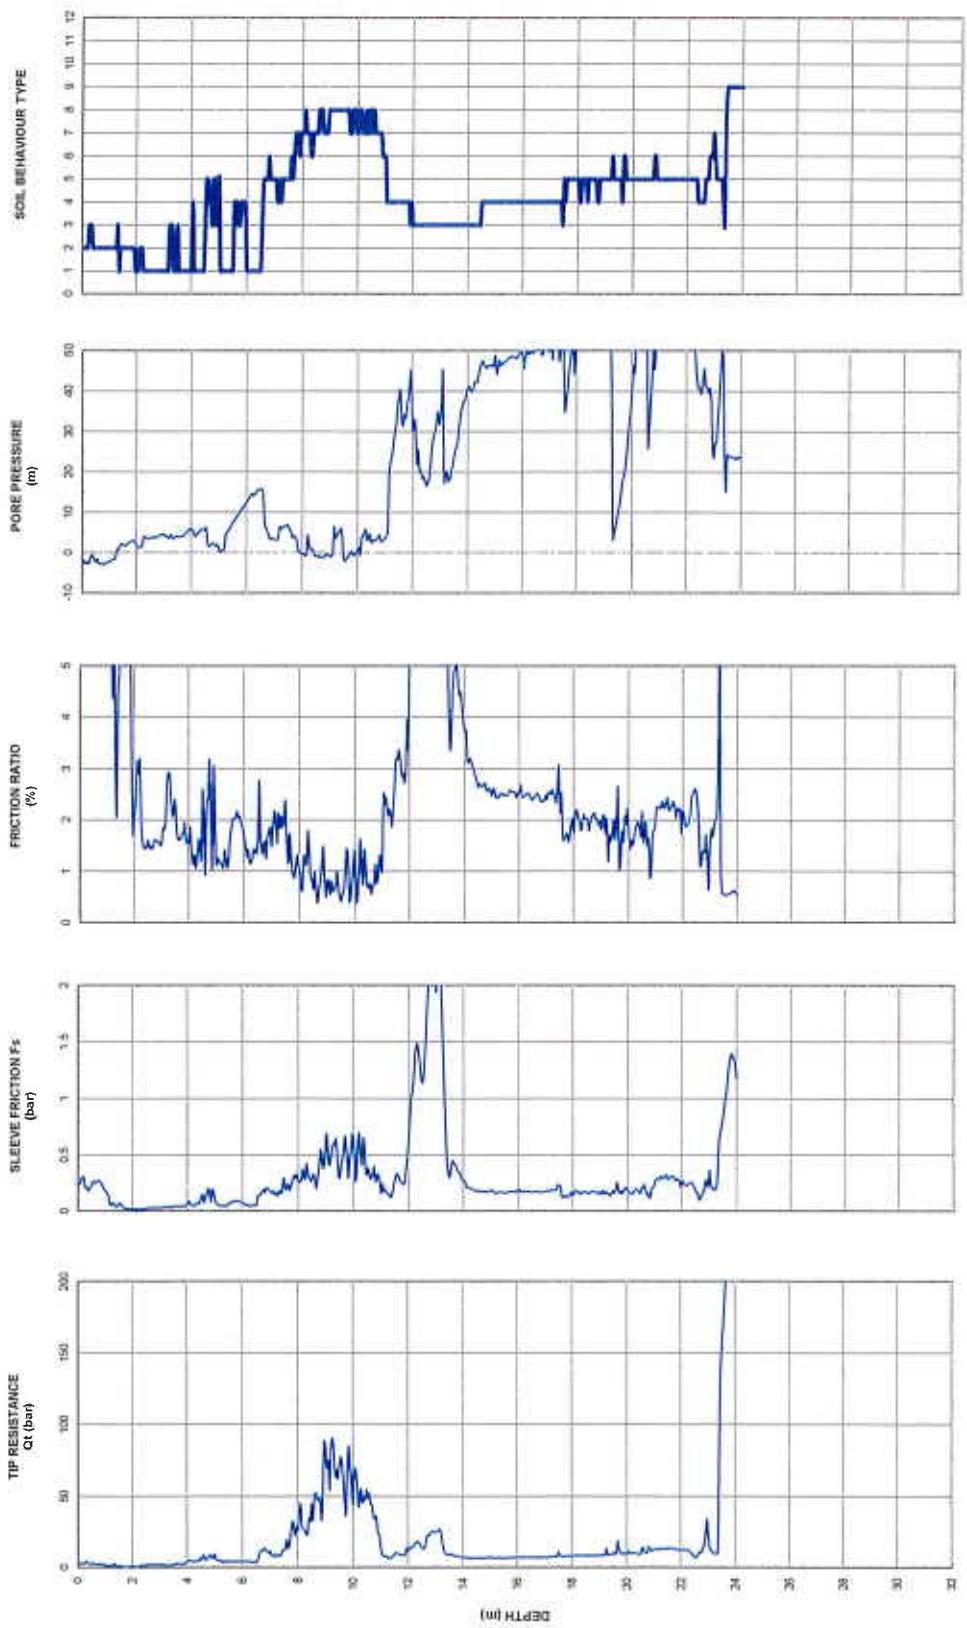
15-Apr-13	Onni Group of Companies	GeoPacific Project #: 11219
	Sounding: CPT13-03	Airport Way East of Harris Road, Pitt Meadows, B.C.	Figure: B.03

** Based on Robertson et. al 1986
1 Sensitive Fine Grained
2 Organic Material
3 Clay
4 Silty Clay to Clay
5 Clayey Silt to Silty Clay
6 Sandy Silt to Clayey Silt
7 Silty Sand to Sandy Silt
8 Sand to Silty Sand
9 Sand
10 Gravelly Sand to Sand
11 Very Stiff Fine Grained
12 Sand to Clayey Sand

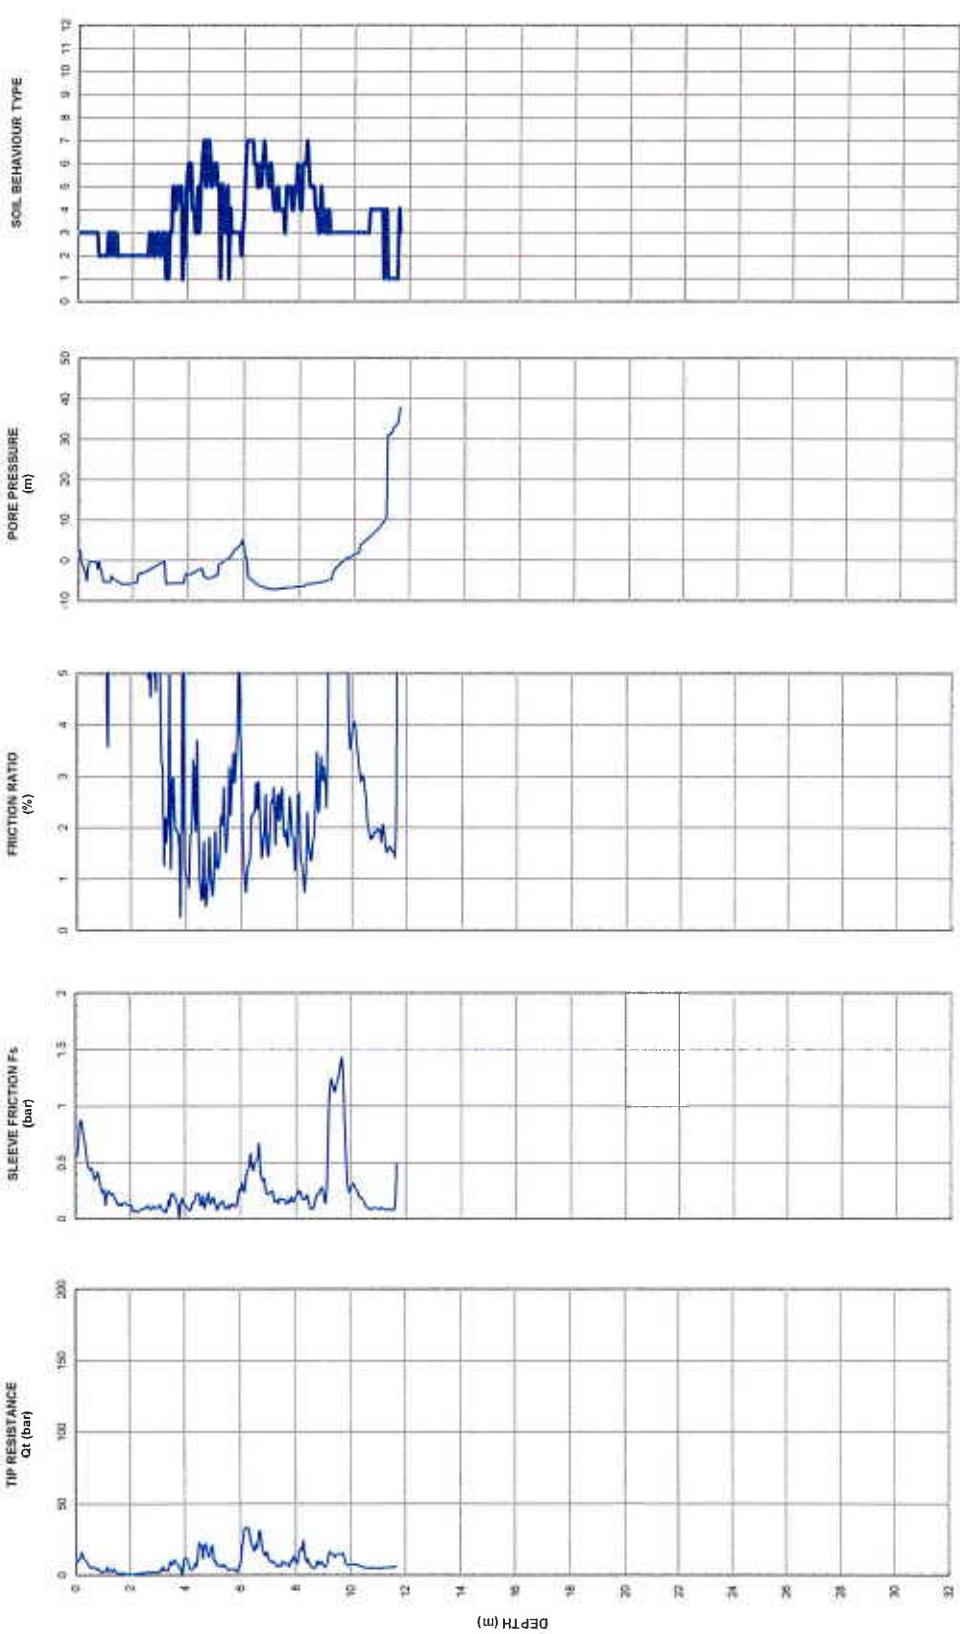
18-Apr-13	Omni Group	GeoPacific Project #: 11219
Sounding: CPT13-05	Airport Way and Harris Road, Pitt Meadows	Figure: B.05

- ** Based on Robertson et. al 1986
- 1 Sensitive Fine Grained
 - 2 Organic Material
 - 3 Clay
 - 4 Silty Clay to Clay
 - 5 Clayey Silt to Silty Clay
 - 6 Sandy Silt to Clayey Silt
 - 7 Silty Sand to Sandy Silt
 - 8 Sand to Silty Sand
 - 9 Sand
 - 10 Gravelly Sand to Sand
 - 11 Very Stiff Fine Grained
 - 12 Sand to Clayey Sand

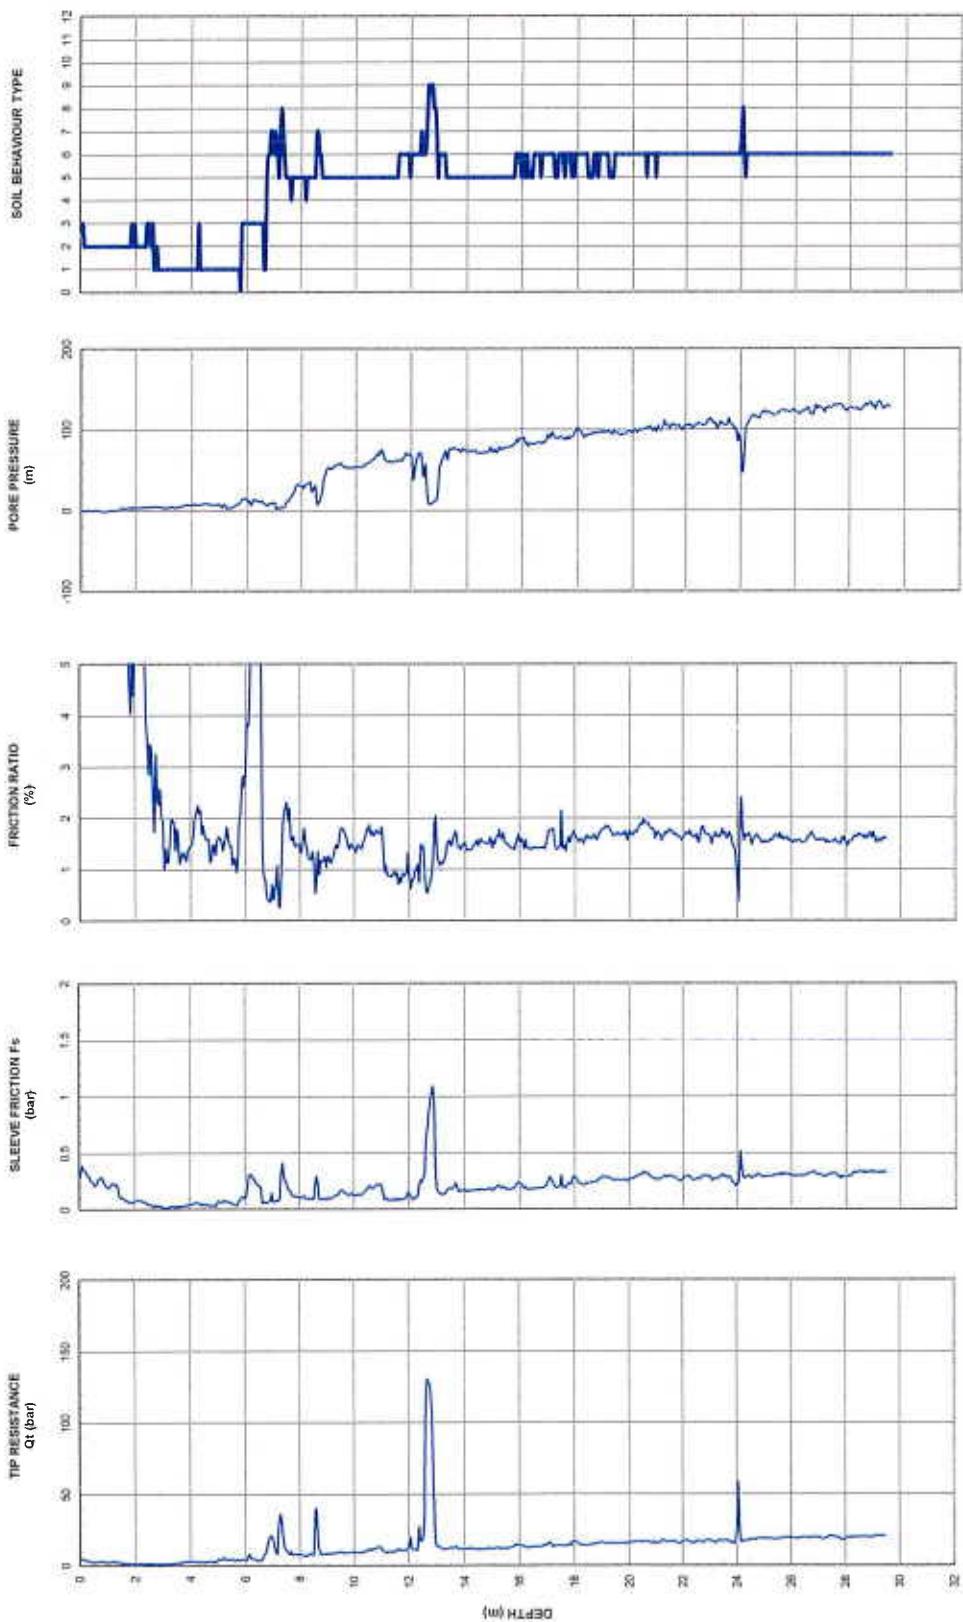
18-Apr-13	Omni Group	GeoPacific Project #: 11219
Sounding: CPT13-07	Airport Way and Harris Road, Pitt Meadows		Figure: B.07

- 1 Sensitive Fine Grained
- 2 Organic Material
- 3 Clay
- 4 Silty Clay to Clay
- 5 Clayey Silt to Silty Clay
- 6 Sandy Silt to Clayey Silt
- 7 Silty Sand to Sandy Silt
- 8 Sand to Silty Sand
- 9 Sand
- 10 Gravelly Sand to Sand
- 11 Very Stiff Fine Grained
- 12 Sand to Clayey Sand

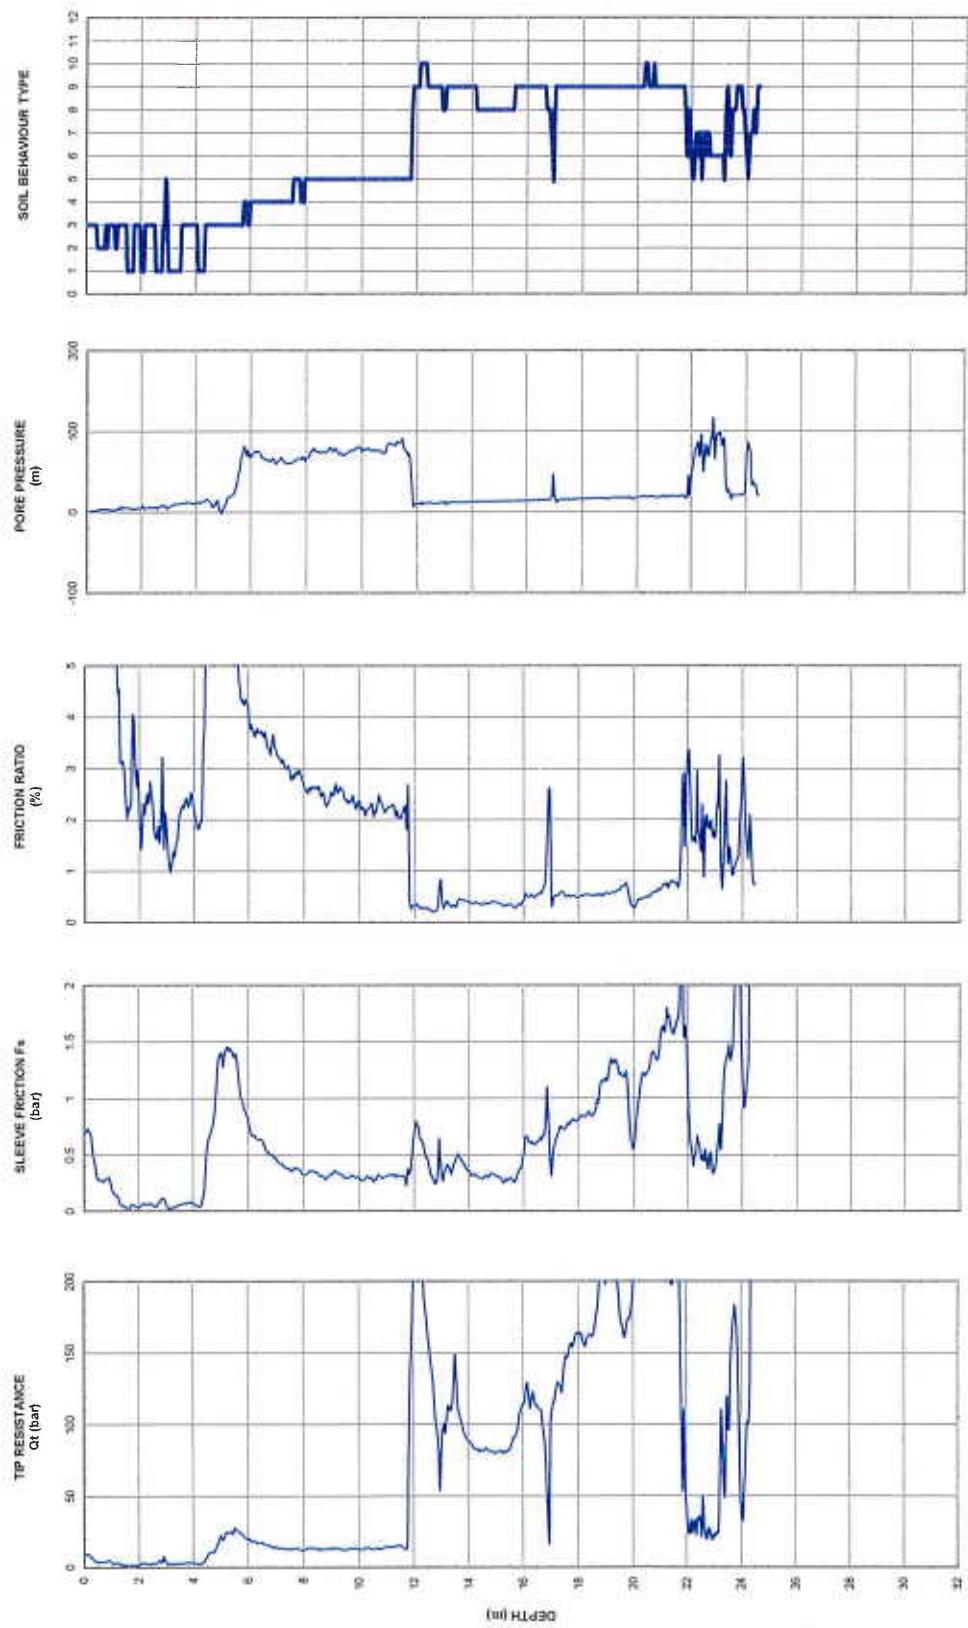
18-Apr-13	Omni Group	GeoPacific Project #: 111219
Sounding: CPT13-08	Airport Way and Harris Road, Pitt Meadows	Figure: B.08

- 1 Sensitive Fine Grained
- 2 Organic Material
- 3 Clay
- 4 Silty Clay to Clay
- 5 Clayey Silt to Silty Clay
- 6 Sandy Silt to Clayey Silt
- 7 Silty Sand to Sandy Silt
- 8 Sand to Silty Sand
- 9 Sand

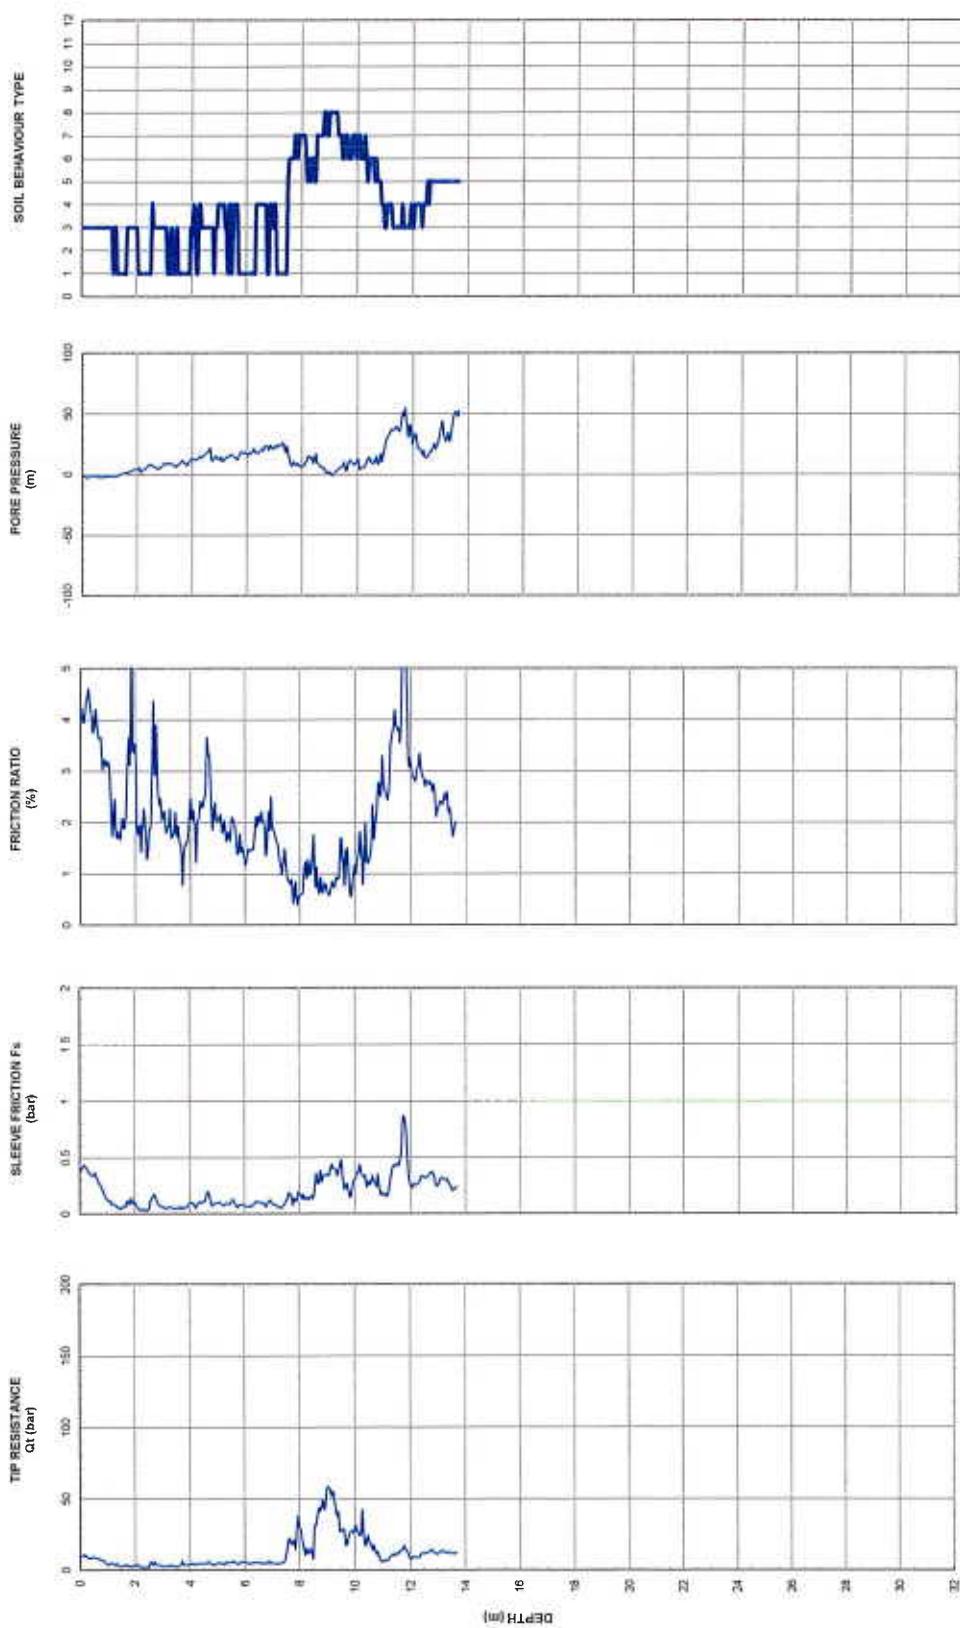
18-Apr-13	Omni Group	GeoPacific Project #: 11219
Sounding: CPT13-09	Airport Way and Harris Road, Pitt Meadows		Figure: B.09

** Based on Robertson et. al 1986
 1 Sensitive Fine Grained
 2 Organic Material
 3 Clay
 4 Silty Clay to Clay
 5 Clayey Silt to Silty Clay
 6 Sandy Silt to Clayey Silt
 7 Silty Sand to Sandy Silt
 8 Sand to Silty Sand
 9 Sand
 10 Gravelly Sand to Sand
 11 Very Stiff Fine Grained
 12 Sand to Clayey Sand

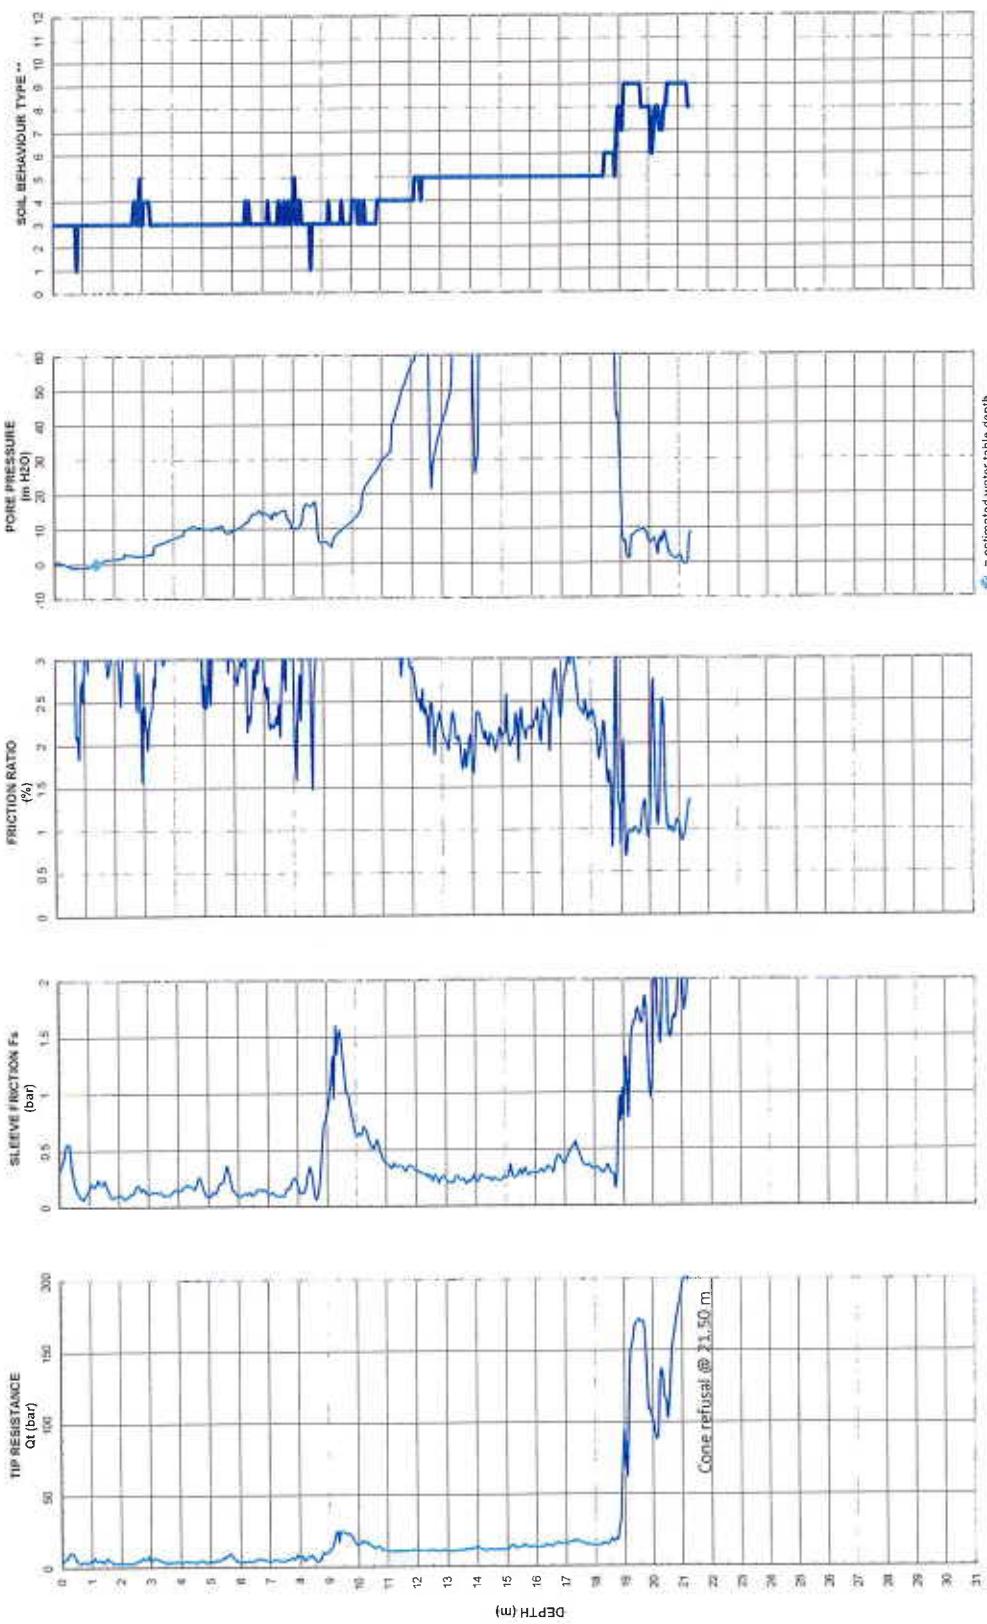
GeoPacific Consultants Ltd.	24-Apr-15	ONNI CONTRACTING LTD	GeoPacific Project #: 11219
	Sounding: CPT15-04	AIRPORT WAY EAST OF HARRIS ROAD, PITT MEADOWS	Figure: B.04

1 Sensitive Fine Grained

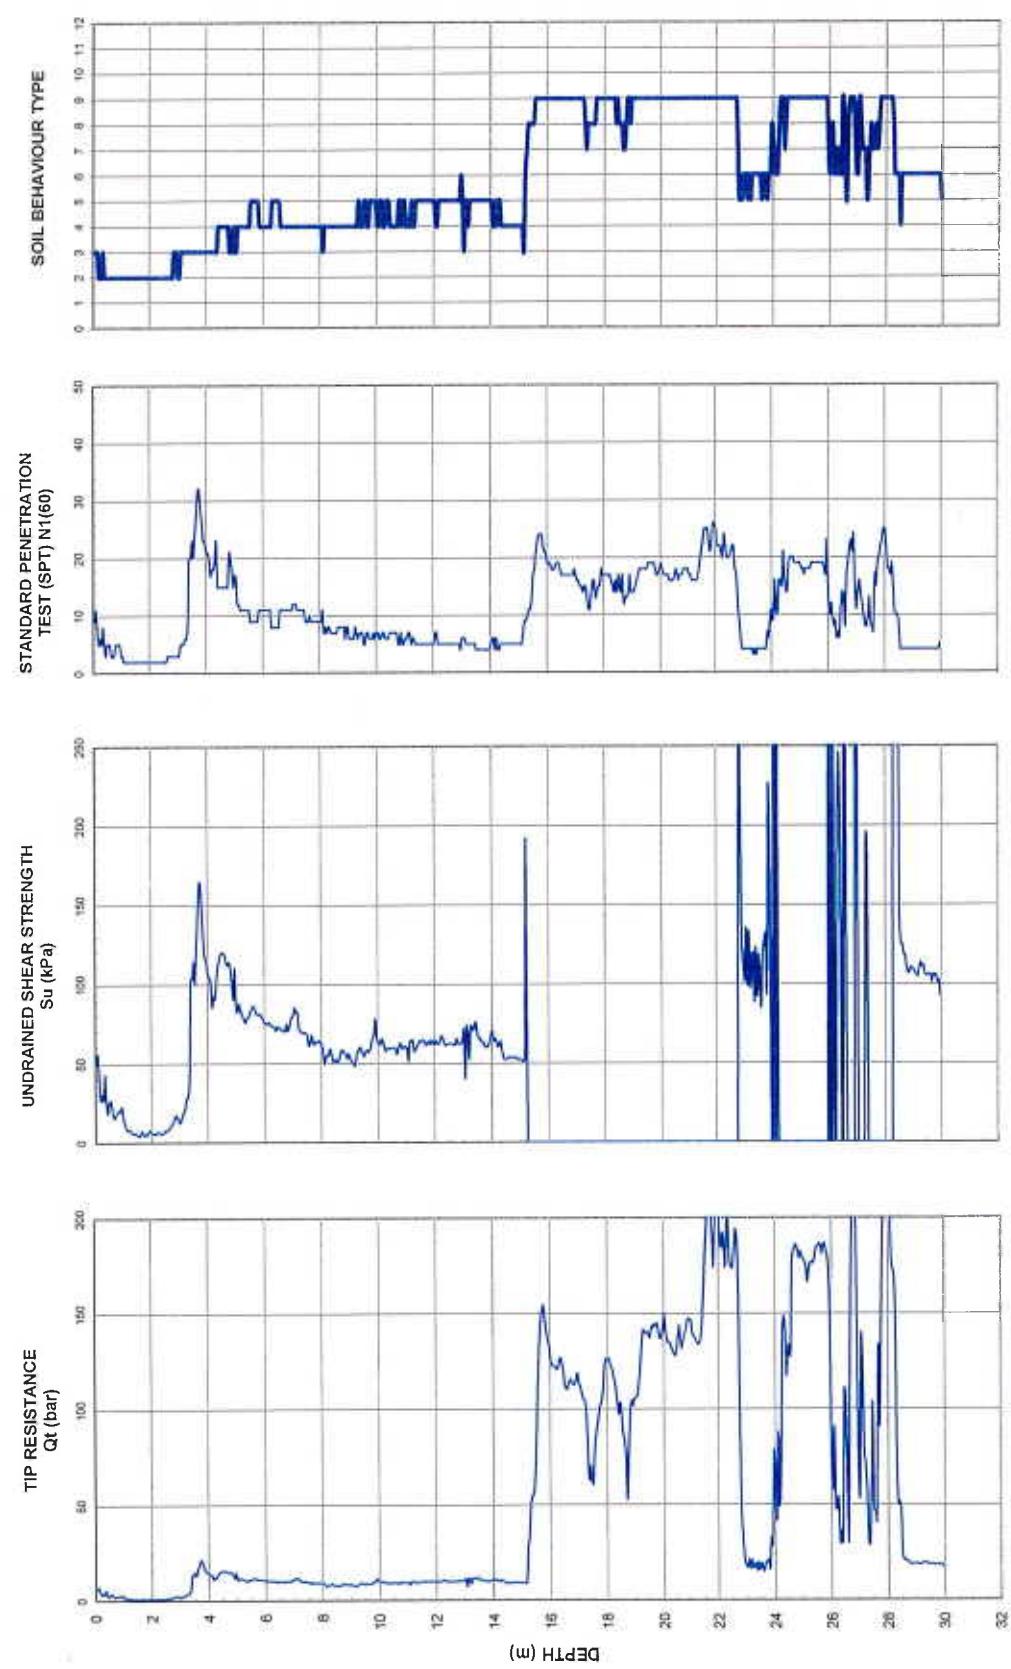
GeoPacific Consultants Ltd.	15-Apr-13	Onni Group of Companies	GeoPacific Project #: 11219
	Sounding: CPT13-02	Airport Way East of Harris Road, Pitt Meadows, B.C.	Figure: C.02

- ** Based on Robertson et. al 1986
- 1 Sensitive Fine Grained
 - 2 Organic Material
 - 3 Clay
 - 4 Silty Clay to Clay
 - 5 Clayey Silt to Silty Clay
 - 6 Sandy Silt to Clayey Silt
 - 7 Silty Sand to Sandy Silt
 - 8 Sand to Silty Sand
 - 9 Sand

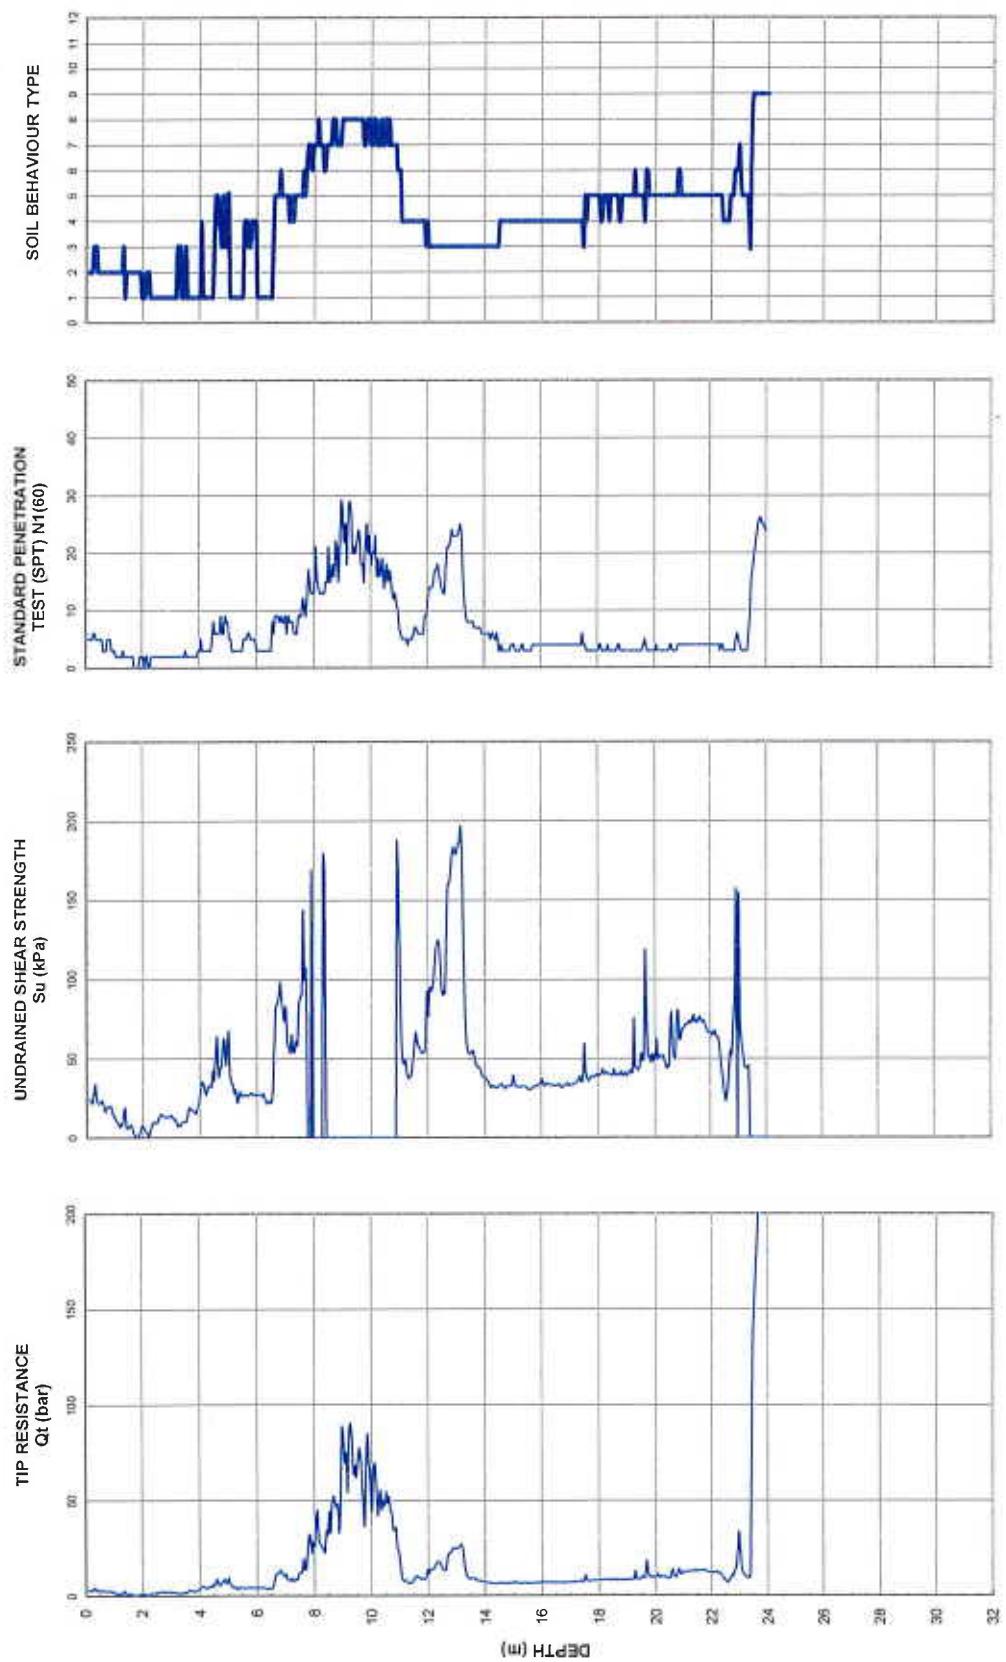
15-Apr-13 Onni Group of Companies GeoPacific Project #: 11219
Sounding: CPT13-03 Airport Way East of Harris Road, Pitt
Meadows, B.C.

- 1 Sensitive Fine Grained
- 2 Organic Material
- 3 Clay
- 4 Silty Clay to Clay
- 5 Clayey Silt to Silty Clay
- 6 Sandy Silt to Clayey Silt
- 7 Silty Sand to Sandy Silt
- 8 Sand to Silty Sand
- 9 Sand

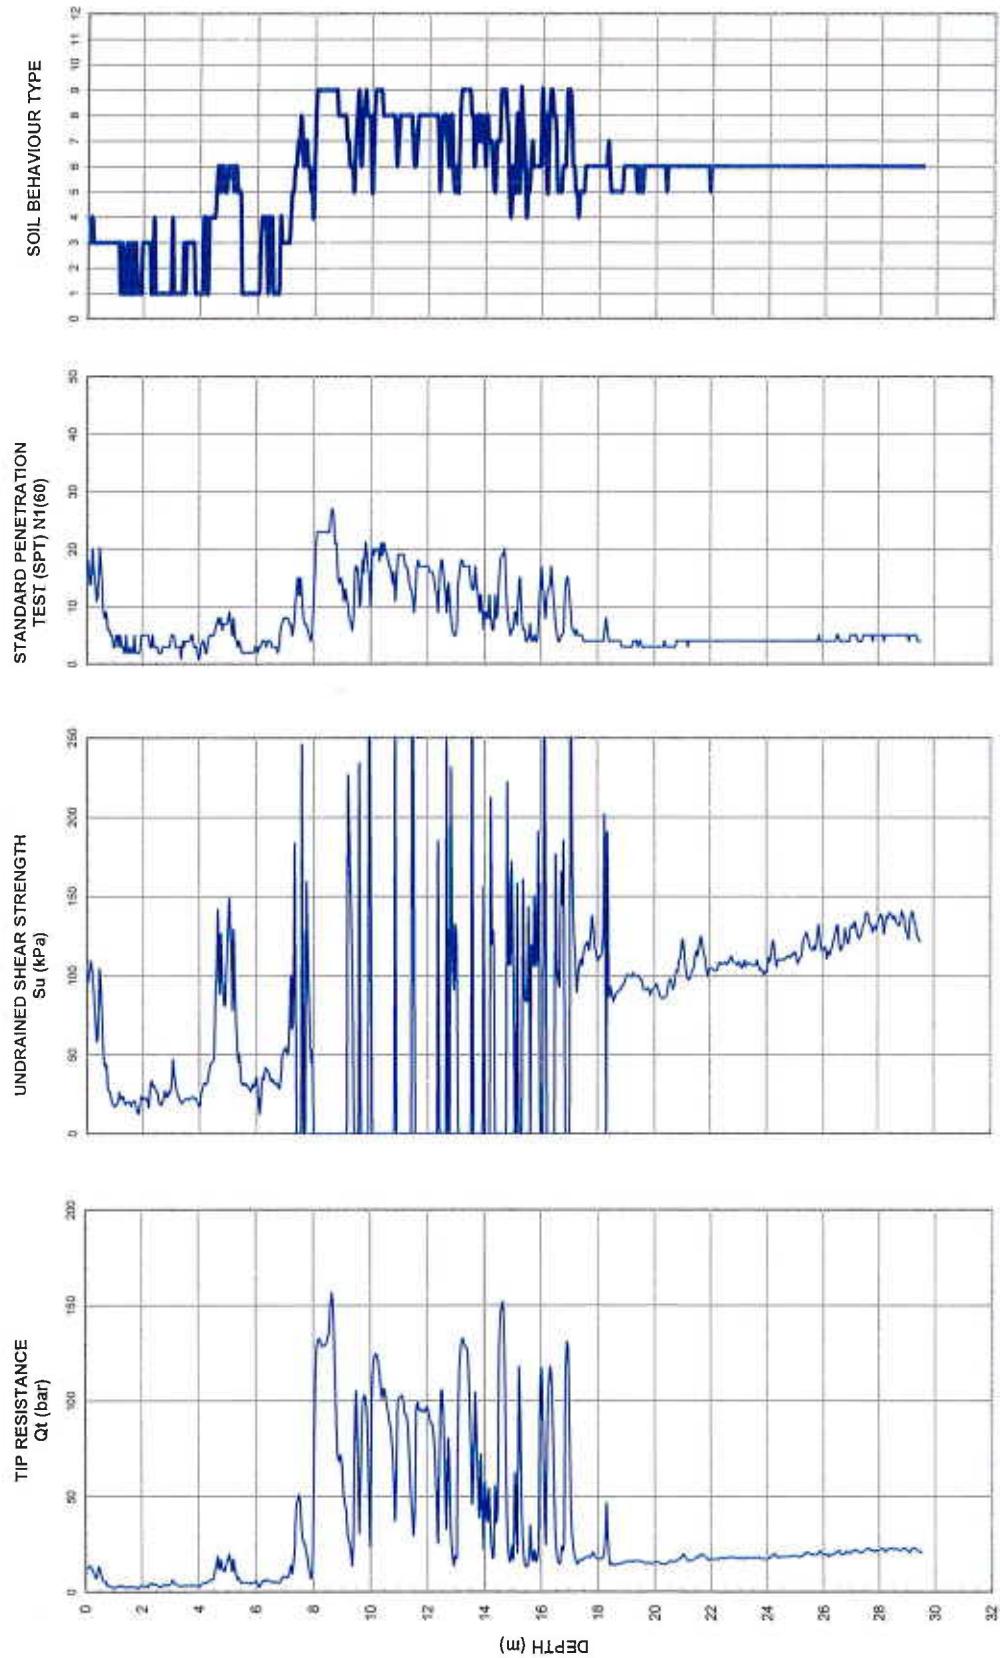
GeoPacific Project #: 11219
Figure: C.06

- 1 Sensitive Fine Grained
- 2 Organic Material
- 3 Clay
- 4 Silty Clay to Clay
- 5 Clayey Silt to Silty Clay
- 6 Sandy Silt to Clayey Silt
- 7 Silty Sand to Sandy Silt
- 8 Sand to Silty Sand
- 9 Sand

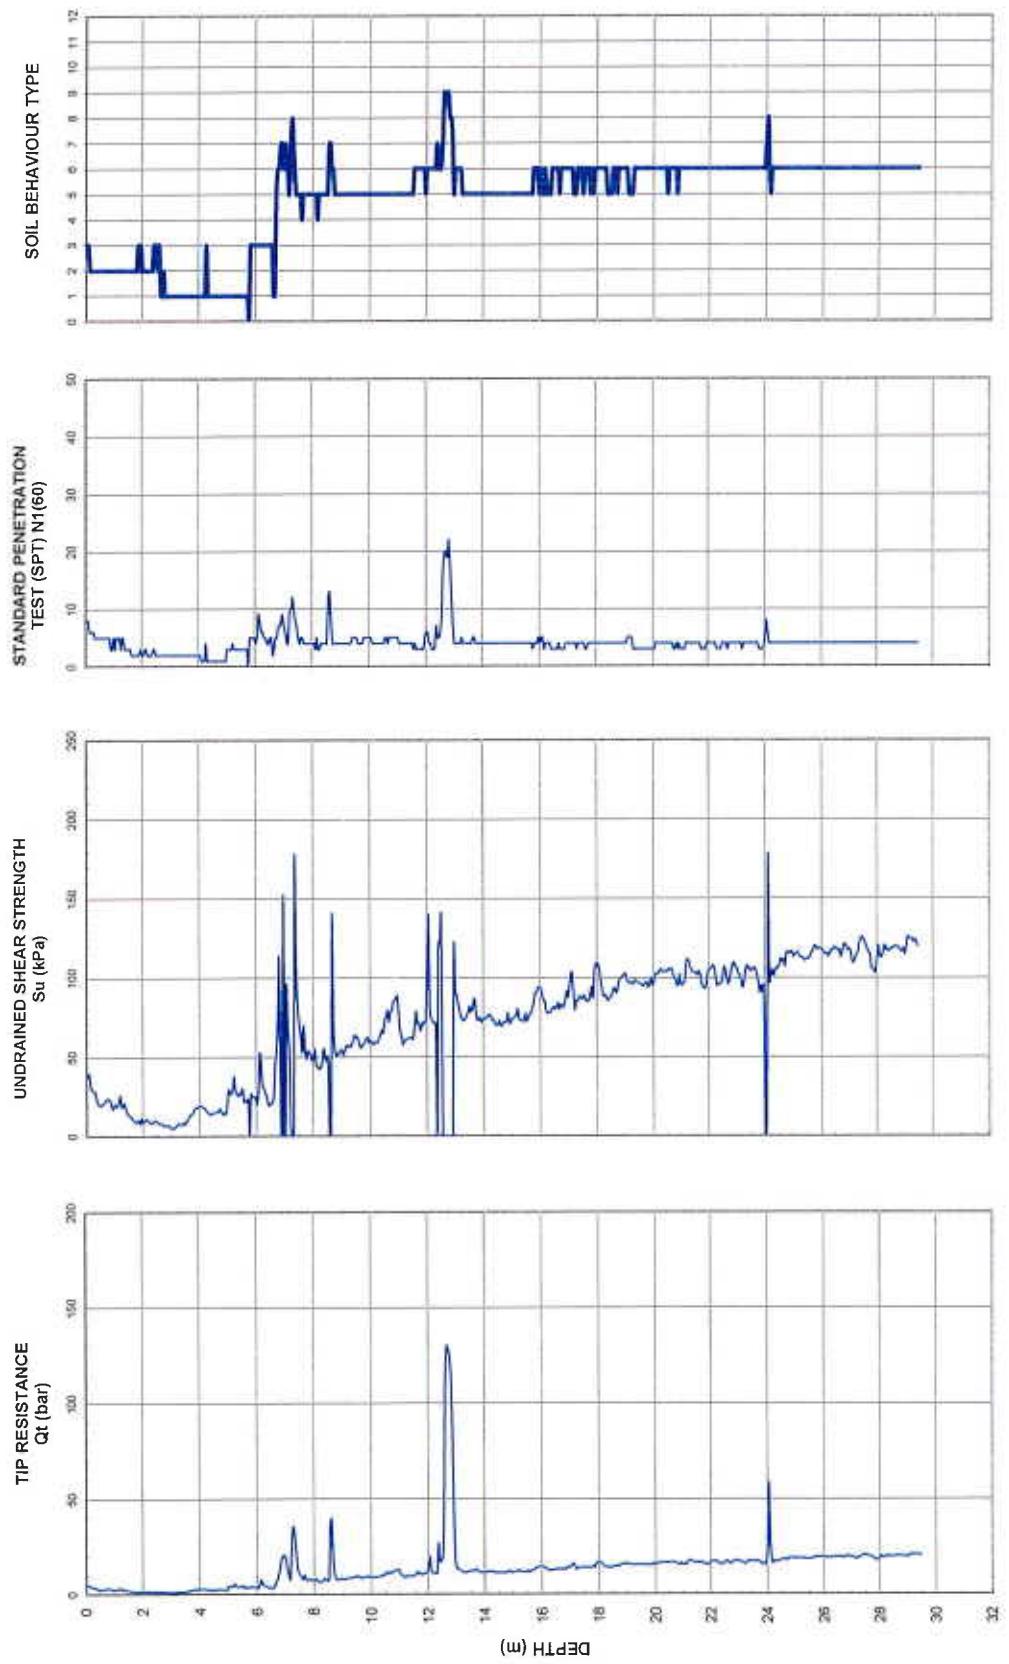
GeoPacific Consultants Ltd.	18-Apr-13	Omni Group	GeoPacific Project #: 11219
	Sounding: CPT13-07	Airport Way and Harris Road, Pitt Meadows	Figure: C.07

** Based on Robertson et. al 1986
 1 Sensitive Fine Grained
 2 Organic Material
 3 Clay
 4 Silty Clay to Clay
 5 Clayey Silt to Silty Clay
 6 Sandy Silt to Clayey Silt
 7 Silty Sand to Sandy Silt
 8 Sand to Silty Sand
 9 Sand
 10 Gravelly Sand to Sand
 11 Very Stiff Fine Grained
 12 Sand to Clayey Sand

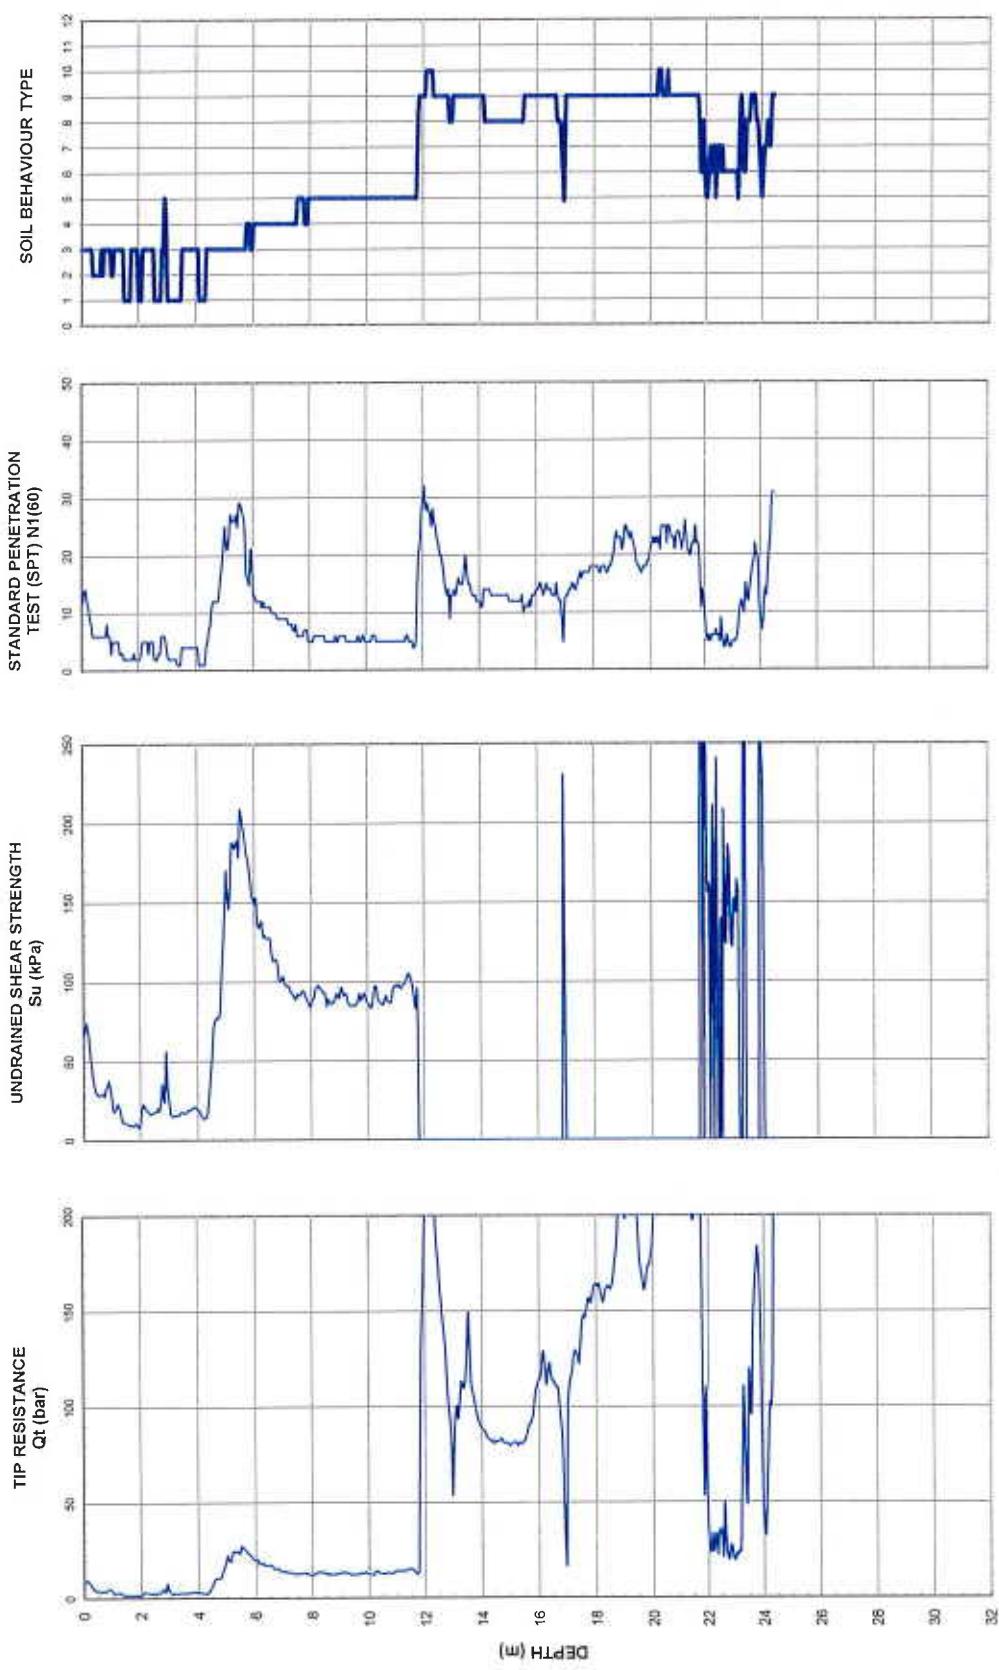
18-Apr-13	Omni Group	GeoPacific Project #: 11219
Sounding: CPT13-08	Airport Way and Harris Road, Pitt Meadows		Figure: C.08

- 1 Sensitive Fine Grained
- 2 Organic Material
- 3 Clay
- 4 Silty Clay to Clay
- 5 Clayey Silt to Silty Clay
- 6 Sandy Silt to Clayey Silt
- 7 Silty Sand to Sandy Silt
- 8 Sand to Silty Sand
- 9 Sand
