Onni Group
300 - 550 Robson Street
Vancouver, BC
V6B 2B7

June 17, 2015
File:11219

**Re: Geotechnical Investigation Report: Proposed Golden Ears Business Park Phase III and IV
Airport Way East of Harris Road, Pitt Meadows, B.C.**

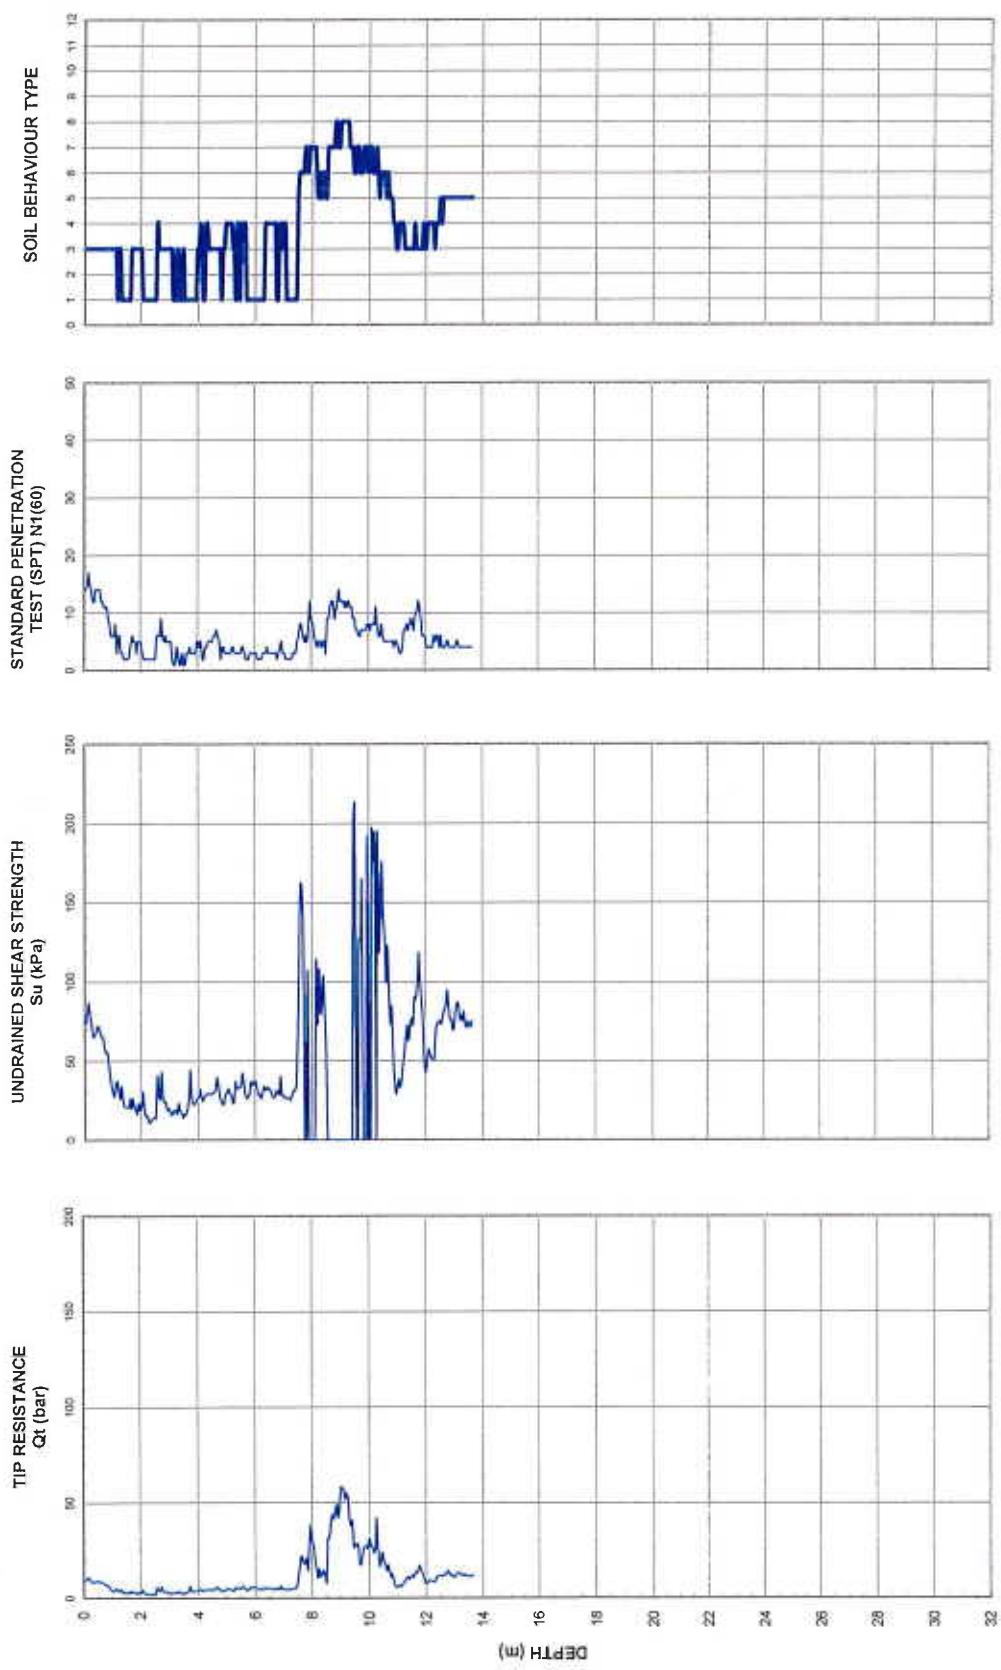
18-Apr-13	Omni Group	GeoPacific Project #: 11219
Sounding: CPT13-09	Airport Way and Harris Road, Pitt Meadows		Figure: C.09

- 1 Sensitive Fine Grained
- 2 Organic Material
- 3 Clay
- 4 Silty Clay to Clay
- 5 Clayey Silt to Silty Clay
- 6 Sandy Silt to Clayey Silt
- 7 Silty Sand to Sandy Silt
- 8 Sand to Silty Sand
- 9 Sand

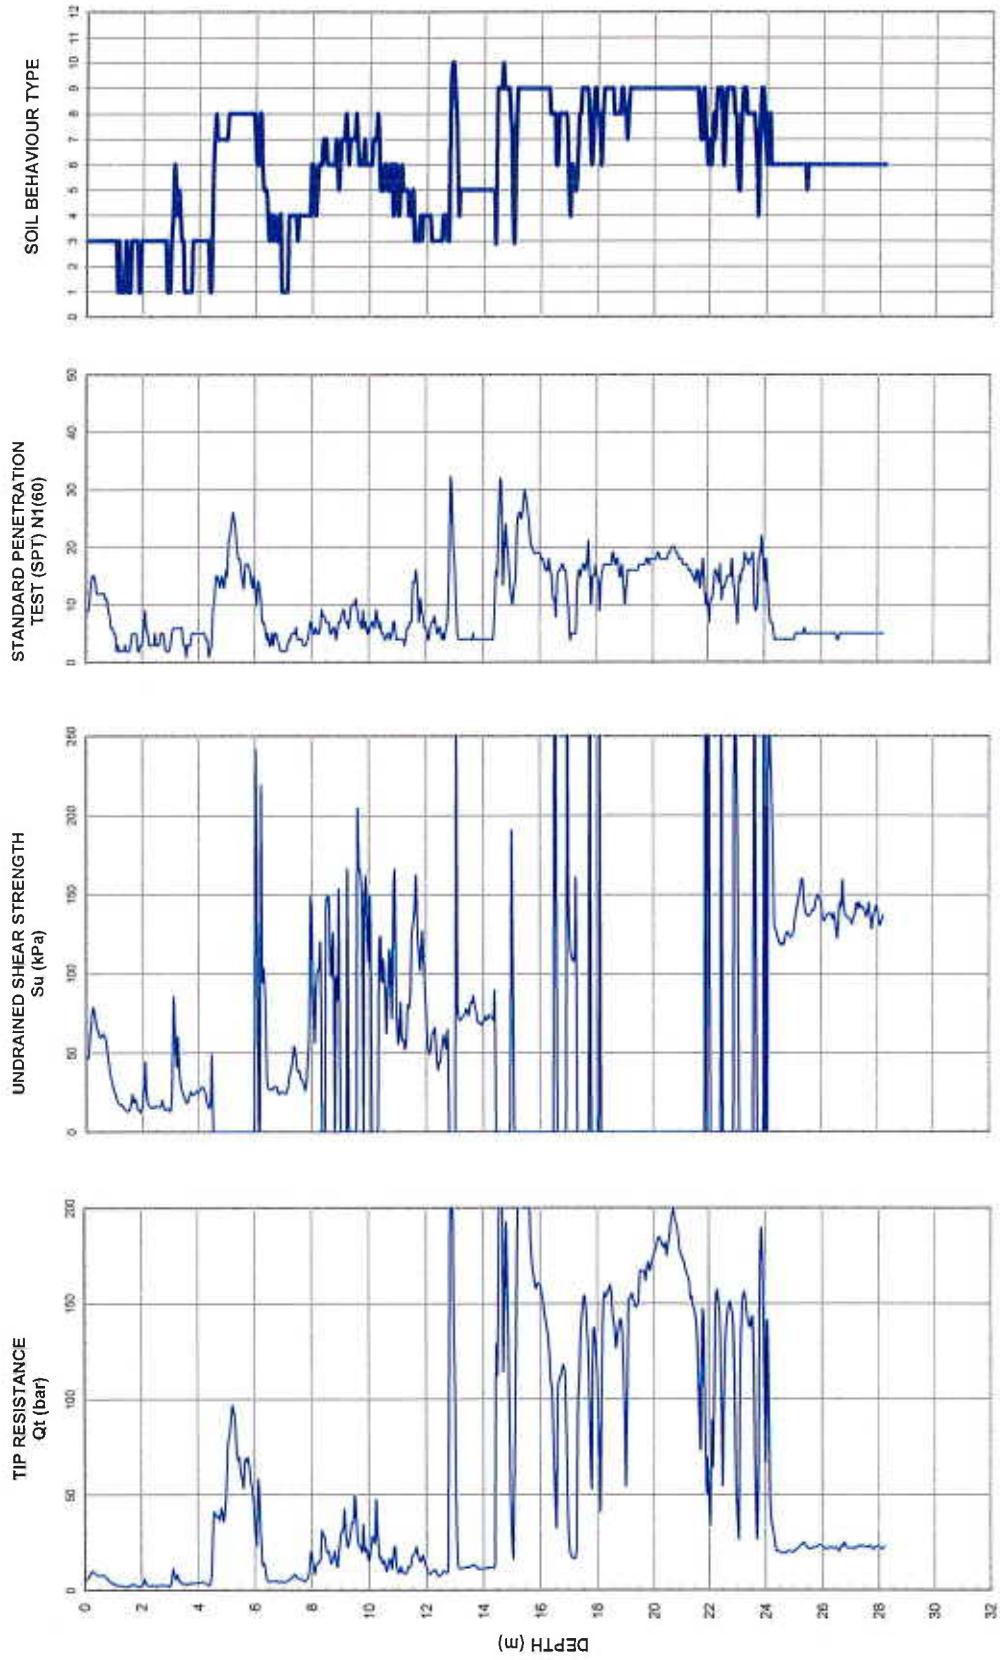
18-Apr-13	Omni Group	GeoPacific Project #: 11219
	Sounding: CPT13-10	Airport Way and Harris Road, Pitt Meadows	Figure: C.10

- 1 Sensitive Fine Grained
- 2 Organic Material
- 3 Clay
- 4 Silty Clay to Clay
- 5 Clayey Silt to Silty Clay
- 6 Sandy Silt to Clayey Silt
- 7 Silty Sand to Sandy Silt
- 8 Sand to Silty Sand
- 9 Sand

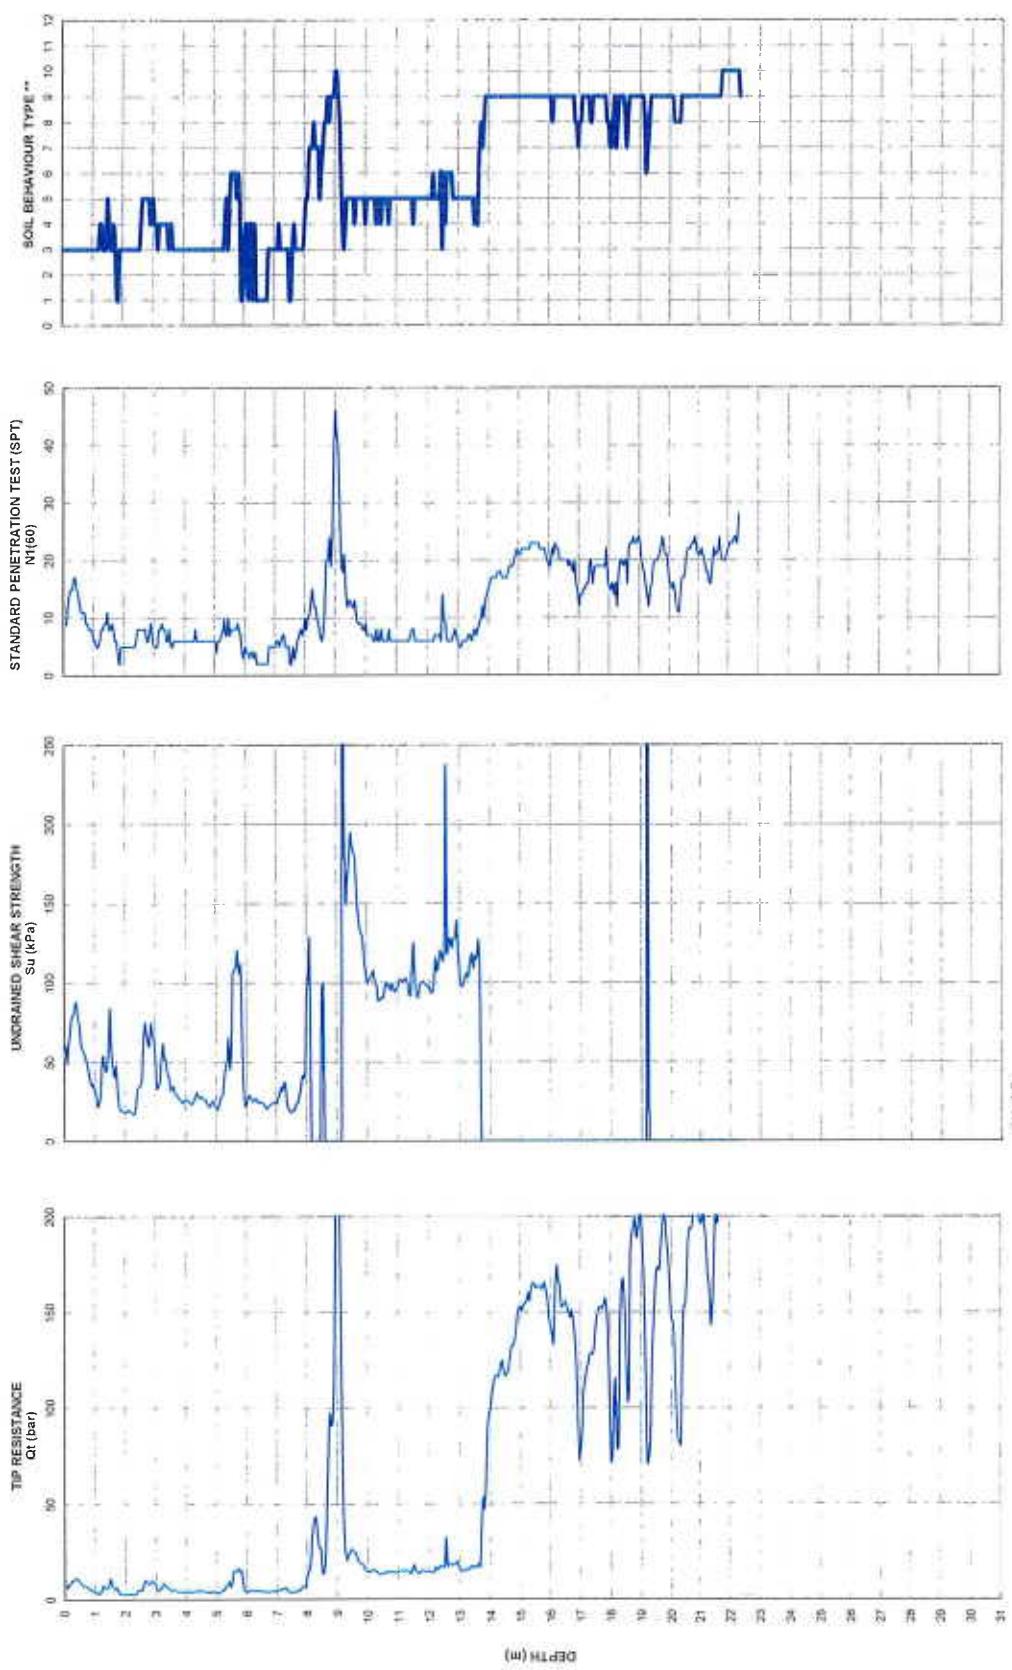
24-Apr-15	ONNI CONTRACTING LTD	GeoPacific Project #: 11219
Sounding: CPT15-02	AIRPORT WAY EAST OF HARRIS ROAD, PITT MEADOWS		Figure: C.02

- ** Based on Robertson et. al 1986
 1 Sensitive Fine Grained
 2 Organic Material
 3 Clay
 4 Silty Clay to Clay
 5 Clayey Silt to Silty Clay
 6 Sandy Silt to Clayey Silt
 7 Silty Sand to Sandy Silt
 8 Sand to Silty Sand
 9 Sand

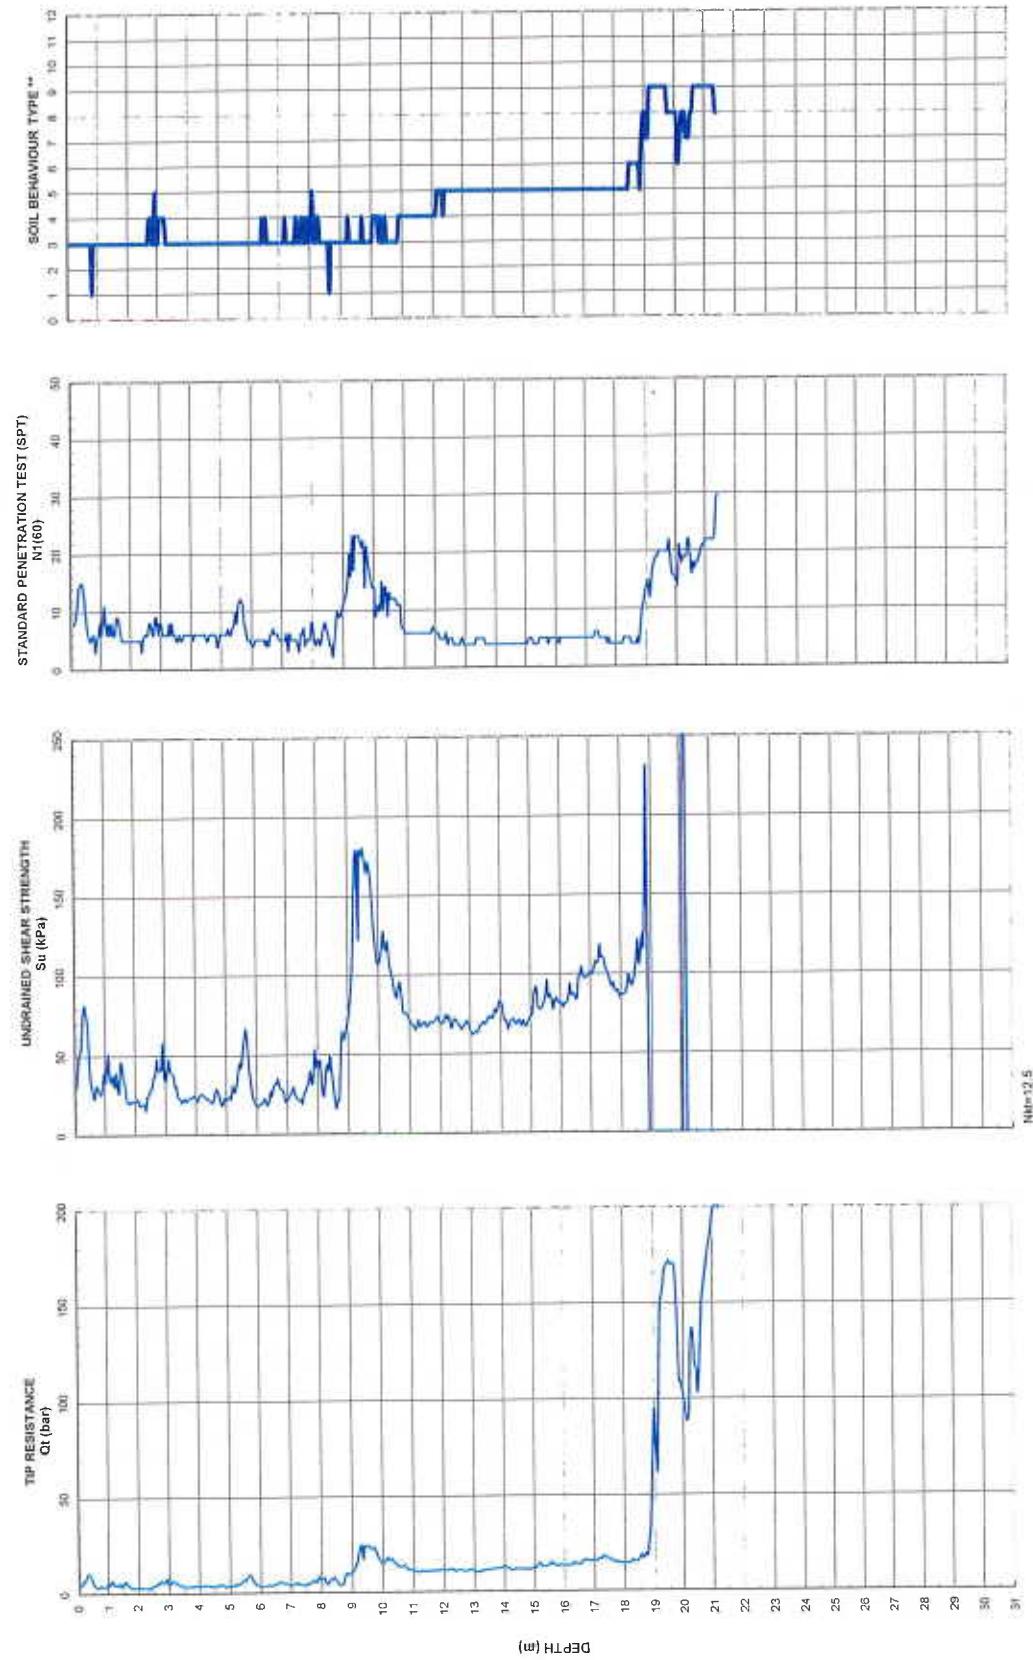
GeoPacific Consultants Ltd.	24-Apr-15	ONNI CONTRACTING LTD	GeoPacific Project #: 11219
	Sounding: CPT15-04	AIRPORT WAY EAST OF HARRIS ROAD, PITT MEADOWS	Figure: C.04

** Based on Robertson et. al 1986
1 Sensitive Fine Grained
2 Organic Material
3 Clay
4 Silty Clay to Clay
5 Clayey Silt to Silty Clay
6 Sandy Silt to Clayey Silt
7 Silty Sand to Sandy Silt
8 Sand to Silty Sand
9 Sand
