**GEOTECHNICAL ASSESSMENT  
PROPOSED RESIDENTIAL DEVELOPMENT  
19963 MCNEIL ROAD, PITT MEADOWS, BC**

Document Type: Version 2

Date: January 30, 2025

Project No.: **K-211145-00**

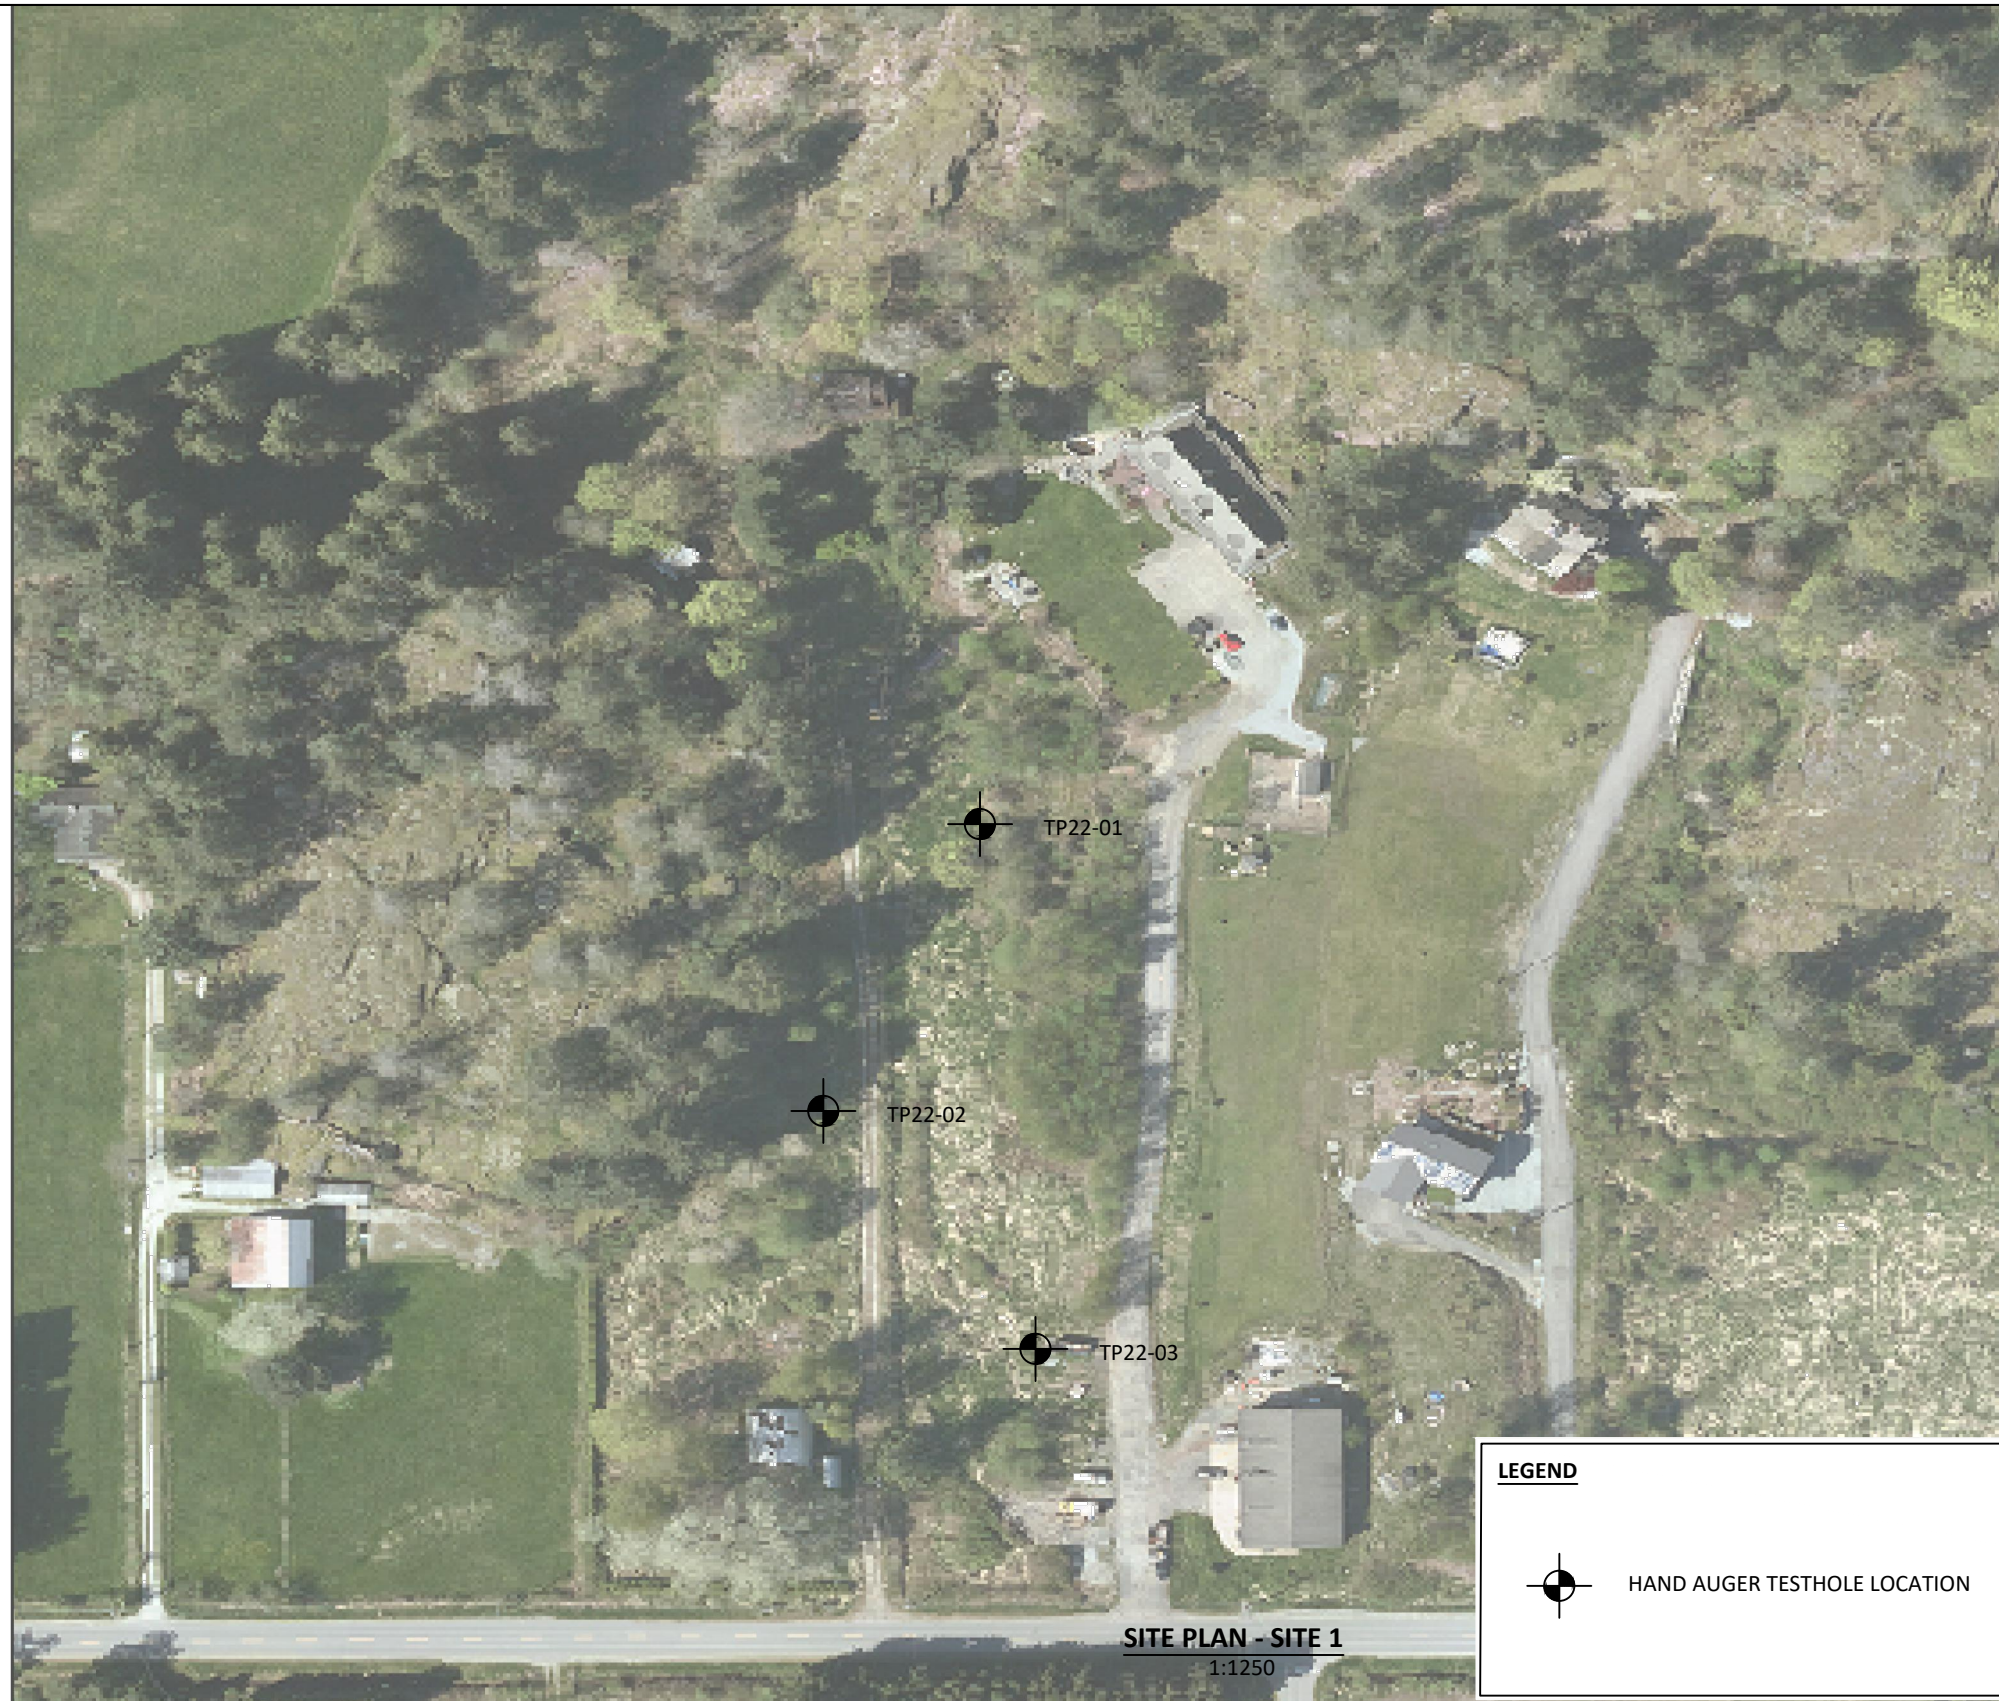
FIGURE 1 - VICINITY MAP & TESTPIT LOCATIONS

Three (3) test pits were excavated by means of an excavator to assess near surface soil conditions in the lower lying flatter areas of the subject property. The test pits were excavated to depths ranging from about 2.0m to 2.3m with locations as shown on the attached *Vicinity Map & Test Pit Locations* attached to this report. Test pits were located, supervised, sampled, and logged by Kontur personnel with samples being returned to Kontur's laboratory for moisture content determination and further visual classification. In general, the test pits encountered a topsoil layer of silty sand with trace gravel up to about 0.3m thick overlying soft clayey silt to silty clay to the bottom of the test pits. Record of Test Pit sheets are included Appendix C to this report.
